FABRIC *of the* FRONTIER

*Prospection, Use, and Re-Use of Stone
from Hadrian's Wall*

Rob Collins, Ian Kille & Kathleen O'Donnell

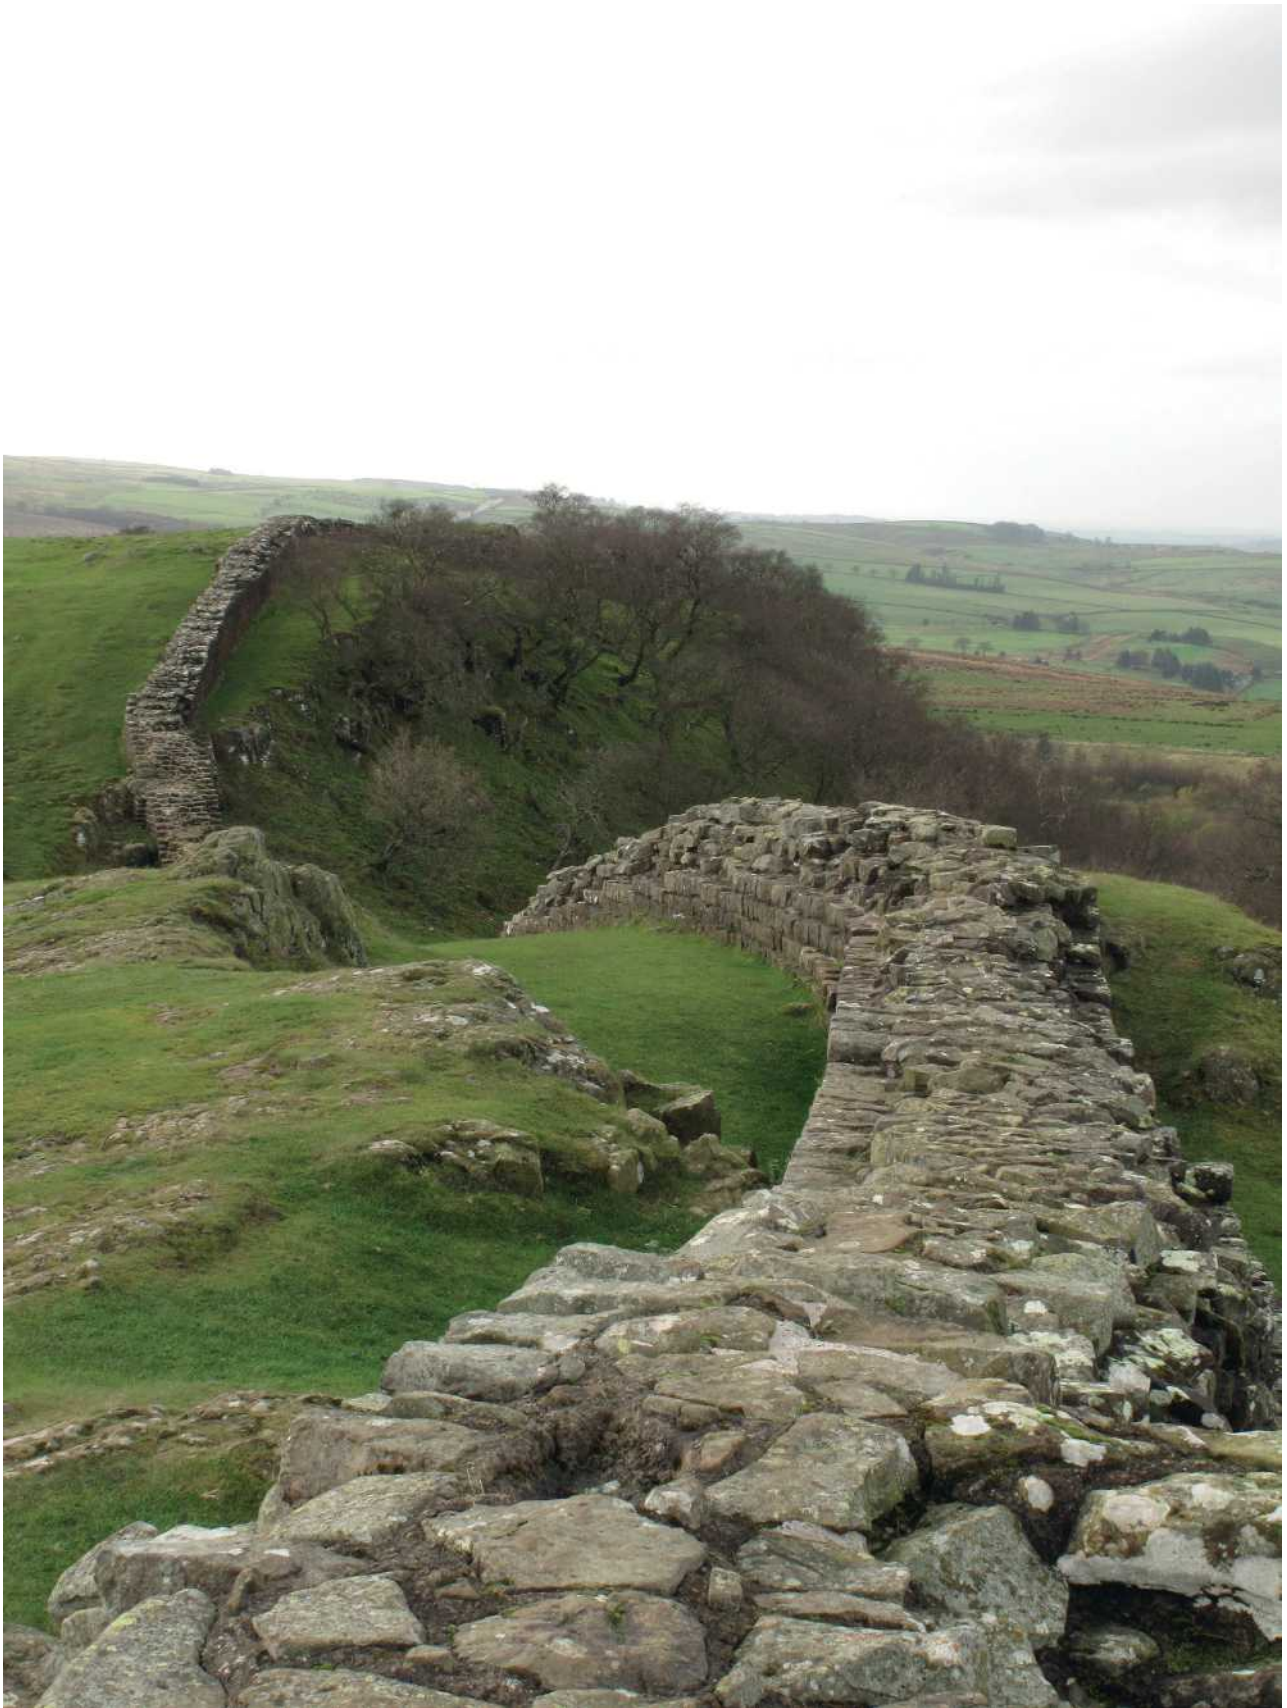
Figure 1.1: The stone curtain of Hadrian's Wall at Walltown Crag, looking west as the line of the Wall follows the forward line of the crags. This stretch of Wall survives in very good condition, often exceeding 2 m in height.

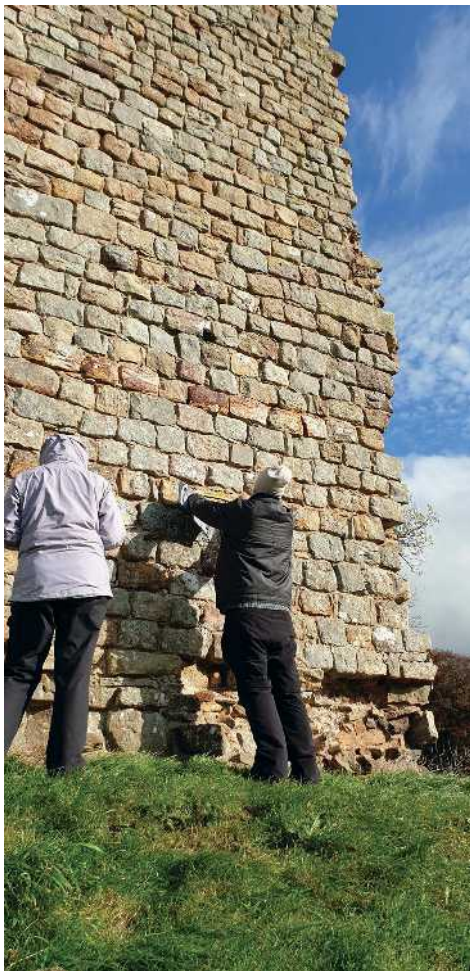
Figure 1.2: WallCAP volunteers recording stone fabric at Thirlwall Castle, taking note of morphological and metric aspects of the stone for its use as a building material, and geological attributes of the stone that help to identify its origins and sourcing.

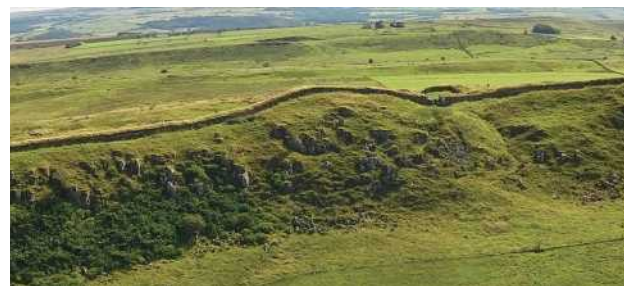
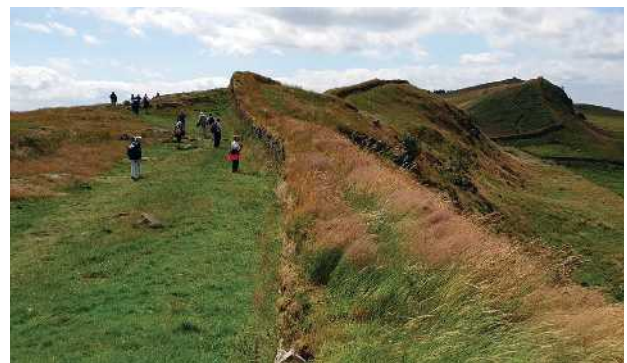
Figure 1.5: (Top) The Wall as it runs atop the crags in Wallmile 37, west of Housesteads fort, as viewed from the air to the north. (Bottom) The same stretch of Wall, looking west, from the ground. Note the changing elevation of the crags, which are not a uniform height.

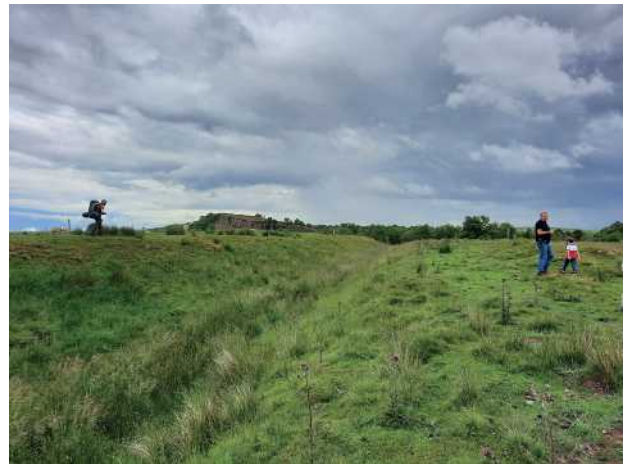
Figure 1.8: The ditch and berm north of the Wall at Carvoran, looking east. Here the ditch has a V-shaped profile, with the base of the ditch indicated by the taller grasses and reeds. The land immediately to the right of the ditch formed the berm. The stone curtain is not visible to any surviving height at this location.

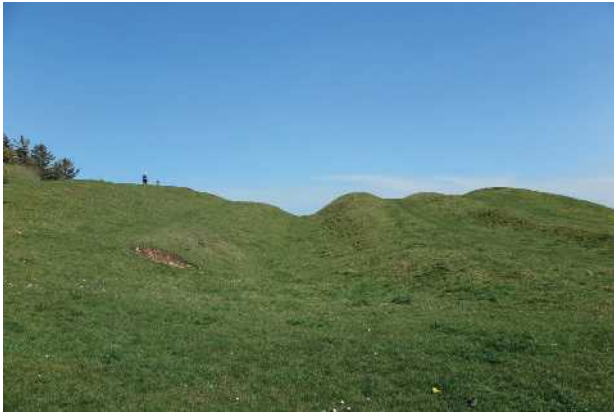
Figure 1.9: The Vallum at Down Hill, looking east. The V-shaped ditch of the Vallum has a mound to its north and south. The Vallum survives in variable condition, with it being completely destroyed at some locations.

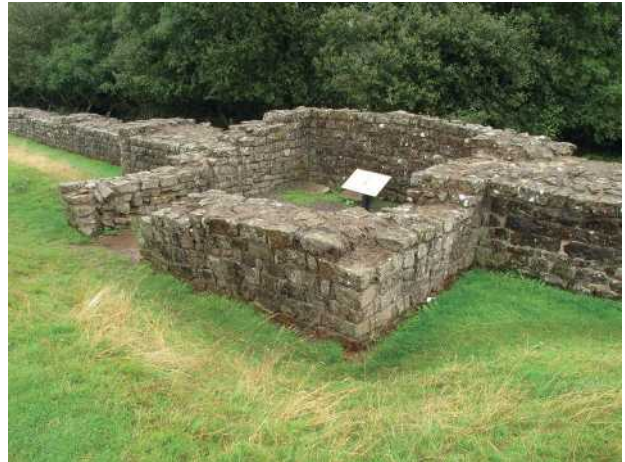
Figure 1.10: Turret 48b, east of Willowford Farm, looking into the low surviving courses of the structure from the southeast.

Along the line of the curtain was a series of distinct structures: turrets, milecastles, and forts. Turrets are towers, built to a square or sub-square plan, and found every one-third of a Roman mile along the curtain (Fig. 1.10). Their function seems to have been simple – to act as elevated observation platforms for the immediate vicinity of the Wall (ideally for a c. 500–1000-m radius, depending on terrain), and possibly to also provide platforms for signalling (Woolliscroft 1989; Foglia 2014). Milecastles, as the name suggests, were small rectangular fortlets positioned every Roman mile along the curtain, consisting of an outer wall integrally joined to the curtain with a gate through the curtain surmounted by a tower; along with a south gate through its perimeter, a milecastle had the potential to provide access through the Wall every Roman mile, though the true extent of such accessibility is debated (Fig. 1.11). Forts are the largest of the structures found in the Wall corridor (Fig. 1.12). These were the primary bases for the units of the Roman army that garrisoned the Wall, and each fort consisted of a number of buildings to house and support the unit(s) in residence. All forts also had four primary gates and two secondary gates; the primary north gate provided access through the

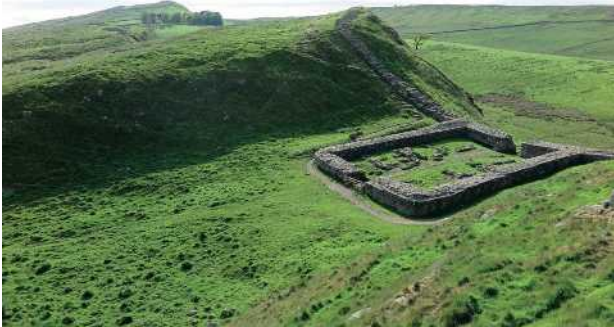
Figure 1.11: Milecastle 39, looking west. Note the breaks in the north and south walls of the structure, which provided gateway access through the line of the curtain.

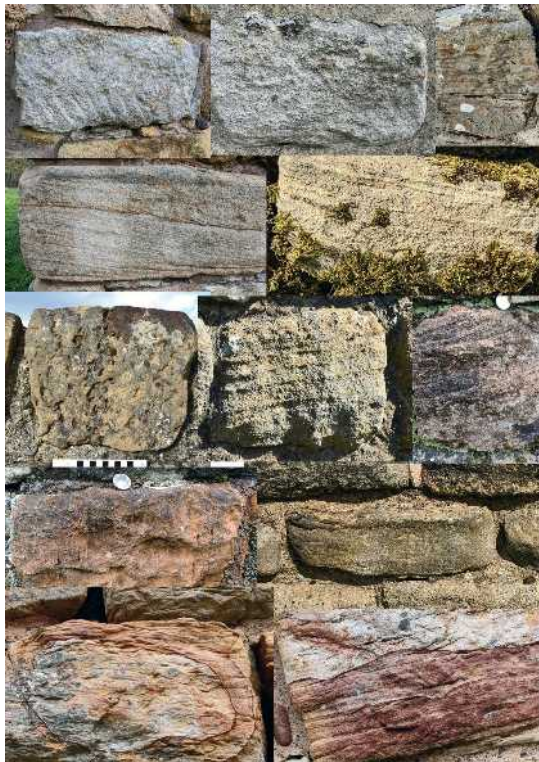
Figure 2.2: Examples of the range of colours and textures in Wall-stones from the Carboniferous strata.

Sandstones, which contribute the greatest volume of material to the Wall, are particularly significant and typically derive from one of three geological periods: the Carboniferous, the Permian, and the Triassic. The Carboniferous sandstones are the most diverse in colours and textures. They range in colour through white, yellows, buff, browns, and purples and in grain size and sorting from fine well-sorted sandstones to coarse gritty poorly sorted sandstones (Fig. 2.2). The Carboniferous sandstones also incorporate a wide range of sedimentary textures both from their fluvial depositional setting (*e.g.*, cross-bedding, rip up clasts) and their diagenesis (*e.g.*, concretions and iron oxide banding (Fig. 2.3)). Permian sandstones, of which the Penrith Sandstones are the most prevalent, are typically salmon pink in colour, fine to coarse grained and well sorted. Sedimentary structures when present reflect their aeolian origin (*e.g.*, low angle, large scale dune-bedding). The Triassic sandstones, of which the St Bees Sandstone is most prevalent, are more purple in colour than the Penrith sandstones and less dusty looking (Fig. 2.4). The St Bees sandstones have sedimentary textures reflecting their fluvial origin and commonly have fine laminar bedding (Fig. 2.5). Diagenetic textures in both the Permian and Triassic sandstones are less common. These descriptions highlight the visible diversity amongst sandstones, but there are other attributes that are variable due to differential formation conditions and which results in varied weathering, erosion, and overall appearance over time.

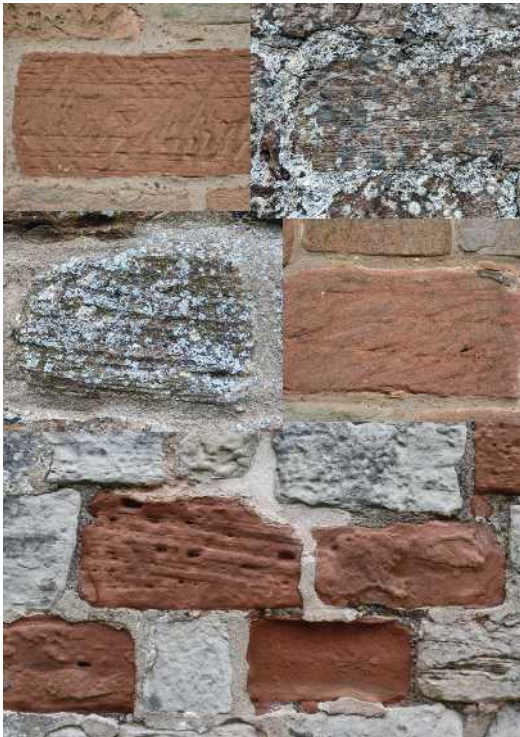
Figure 2.4: Examples of the range of colours and textures in Wall-stones from the St Bees Sandstone Formation in the Triassic strata.

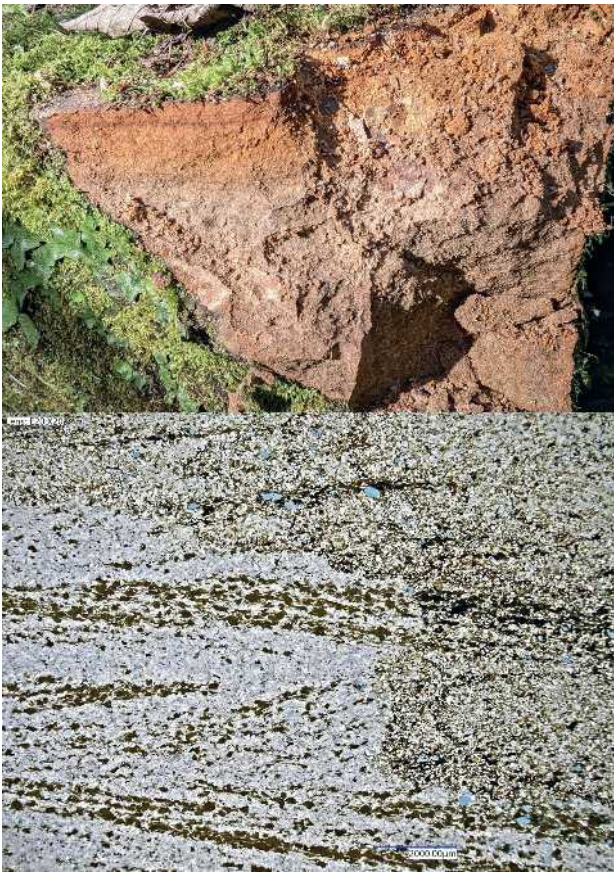
Figure 2.6: Top: Weathered stone in stream bed at Shawk, with fresh stone at the bottom and darker bands of weathered stone toward the top. Bottom: thin section across weathering profile of sandstone from Hartley Bay (HB002) with fresh stone bottom left and the darker more iron rich weathered stone across the top of the image and down the right-hand side.

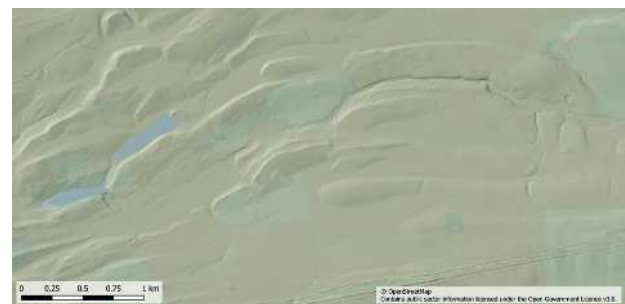
Figure 2.14: LiDAR image of the area north of Housesteads and Carrawburgh. This shows a series of sandstone ridges dipping to the SSE (bottom right of the image) with crag faces (light) facing NNE. Each ridge is discontinuous, some barely 500 m and none more than approximately 4 km in length. Each ridge represents a lens-shaped body of sandstone, which at a given point at outcrop will look like a series of parallel layers. 1 m DSM data © Creative Commons licence CC BY 4.0; LiDAR via OpenStreetMap.

This mode of formation has several consequences. The first is that the sandstone bodies it creates are laterally discontinuous forming broad lens shaped bodies. Examples of this can be seen around Housesteads, clearly visible in the LiDAR image of Figure 2.14. The sandstones may also be diachronous, with what may appear to be a single outcrop of sandstone having formed at different times as the river channel migrates. Additionally, a detailed examination of the composition of individual sandstone units reveals that there may be a complex variety of different sandstone deposits within that one unit (Figs 2.15 and 2.16), each having formed in differing environments. This could include sand bars within the river, migrating ripples within the river channel and channel fill on the inner bend of a meander.

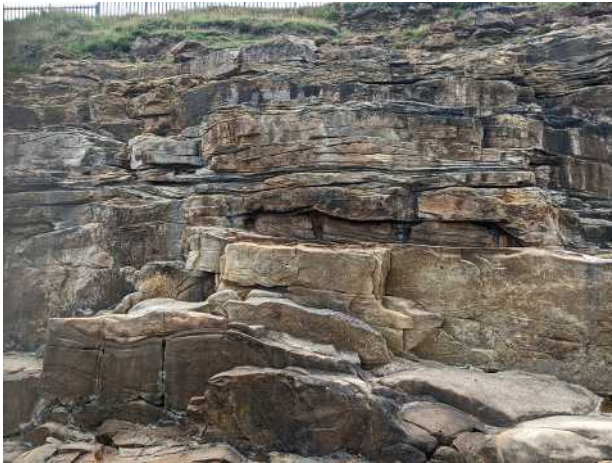
Figure 2.16: The Table Rock Sandstone near Whitley Bay showing complex variation within this sandstone unit.

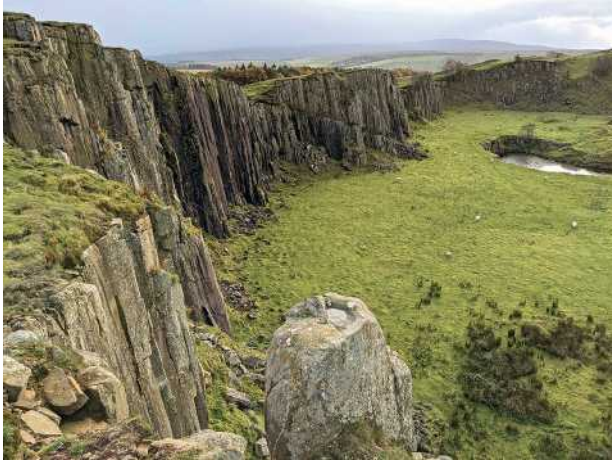
Figure 2.19: Columnar jointing in the Whin Sill in a quarry at Walltown Crag.

In common with many igneous rocks as it cooled beyond its solidus temperature, *c.* 990°C for dolerite, it continued to contract. This contraction is compensated for as a series of polygonal joints initiated at the cooling margin of the sill and running into the body of the sill perpendicular to its margin (Budkewitsch and Robin 1994). This is known as columnar jointing, which in the Whin Sill is fairly crude but nonetheless diagnostic of the igneous nature of this body of rock (Fig. 2.19). The combination of its extreme hardness and jointing which is anything but rectilinear mean that this material was not used by the Romans as facing material. Its plentiful supply in the central sector of the Wall did, however, mean that it was used extensively in the core of the curtain. Crudely shaped subtriangular blocks of Whin Sill are also used in some parts of the central sector of the Wall in the curtain's foundation, as at Sewingshields Crags close to Milecastle 35 (Fig. 2.20).

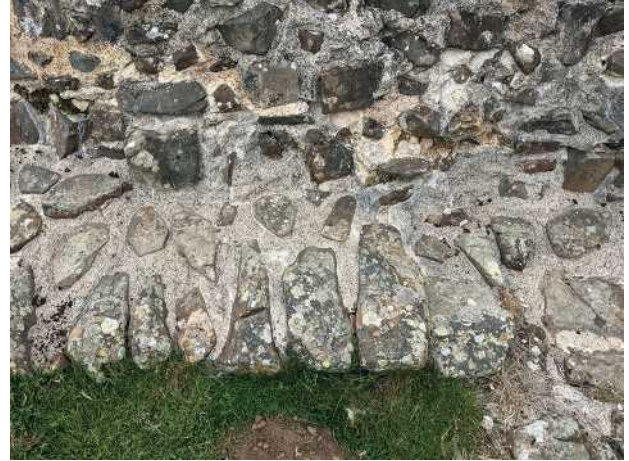
Figure 2.20: Triangular-shaped blocks of whinstone used in the foundations of the Wall at Sewingshields Crag.

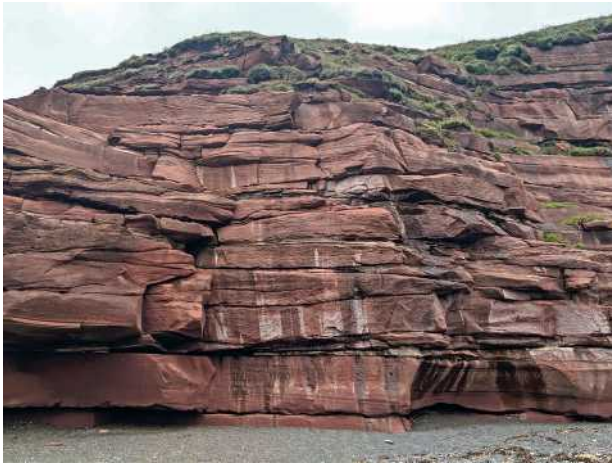
Figure 2.23: Horizontal and cross-bedding structures in the St Bees Sandstone at St Bees Head.

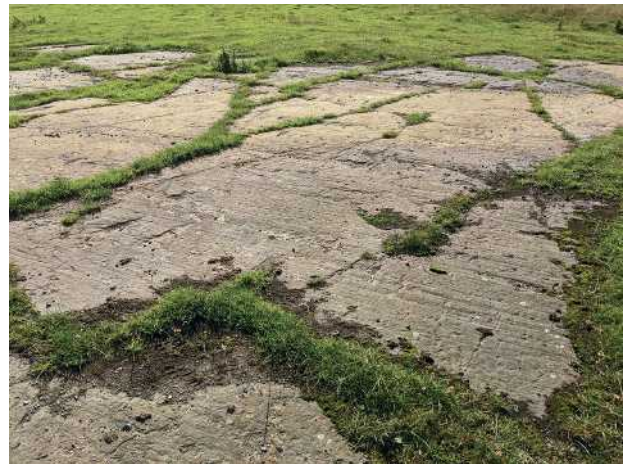
Figure 2.25: Grooves cut into the surface of sandstone by the movement of ice, near Fallowfield.

The combination of the weight of the ice and the entrainment of clasts from clay to boulder size, can make the movement of ice over the land surface very effective at scouring the rock surface (Fig. 2.25). Patterns of erosion are controlled by the nature of the rock which the ice transits. The hardness of the rock governs its resistance to the erosive power of the ice such that hard rocks, for example sandstones and igneous rocks like the Whin Sill, are left in ridges as the softer material around them is eroded away. The orientation of rock layering relative to the direction of ice movement also makes a difference to the way that erosion takes place. Movement of the ice parallel to the layers of rock allows softer layers of rock to be more effectively scoured. This is well displayed in the central sector of the Wall around Housesteads where layers of sandstones and limestones along with the obvious ridge of the Whin Sill are picked out (Fig. 2.14). Softer sediments which have been plucked out by the movement of ice have here been infilled by loughs and mires. Where the movement of ice is discordant with the rock layering the ice tends to smear glacial till into the valleys between ridges of harder material partially

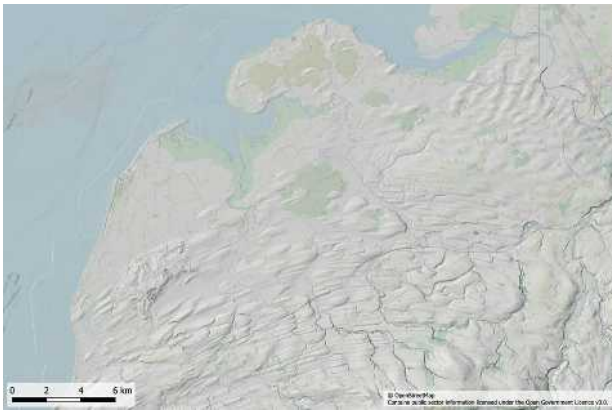
Figure 2.26: Drumlins south of Bowness-on-Solway showing strong alignment E–W along with the drumlins under the Wall at Bowness and Drumburgh. LiDAR via OpenStreetMap.

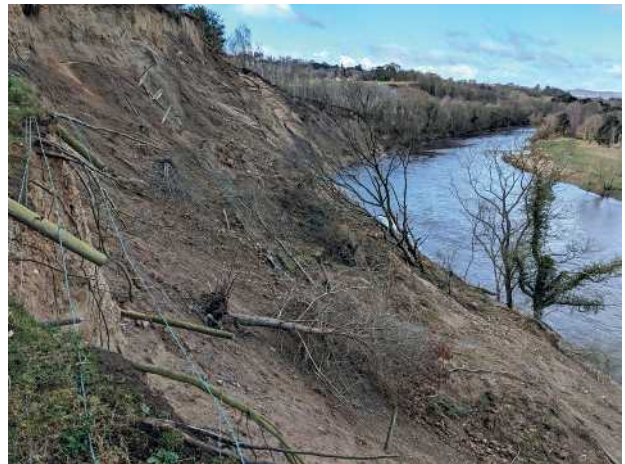
Figure 2.27: Glacio-fluvial deposits at Farnley Scar eroded by the River Tyne into cliffs rising to 55 m.

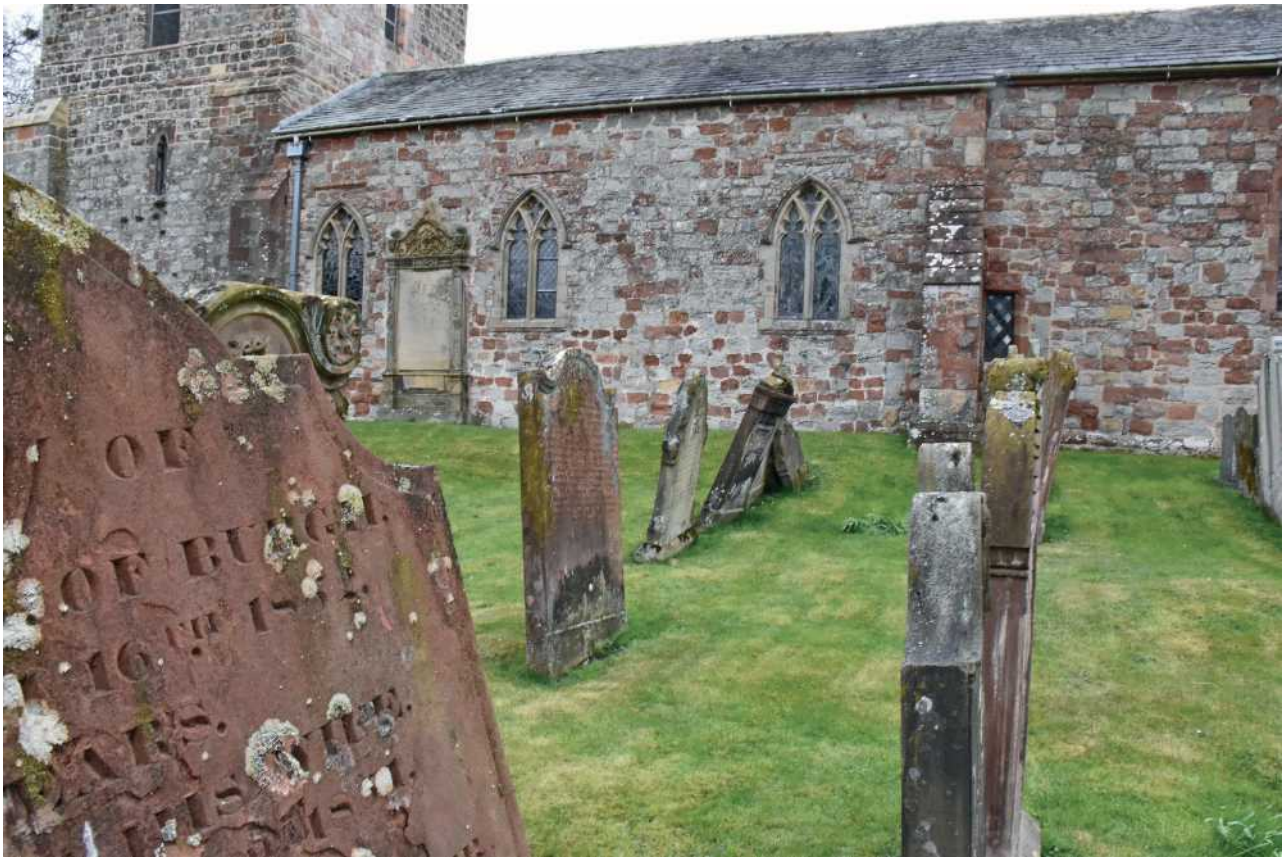
Figure 2.29: Possible re-used Wall stones of St Bees sandstone at St Michael's Church, Burgh-by-Sands. Gravestones also made of St Bees sandstone.

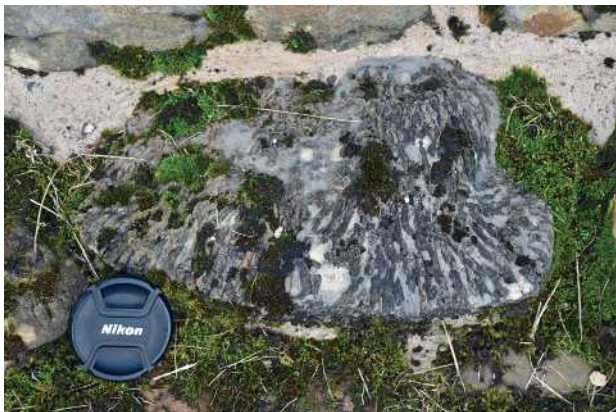
Figure 3.1: Limestone blocks with fossilised *Siphonodendron* used to construct the bridge abutment at Willowford crossing.

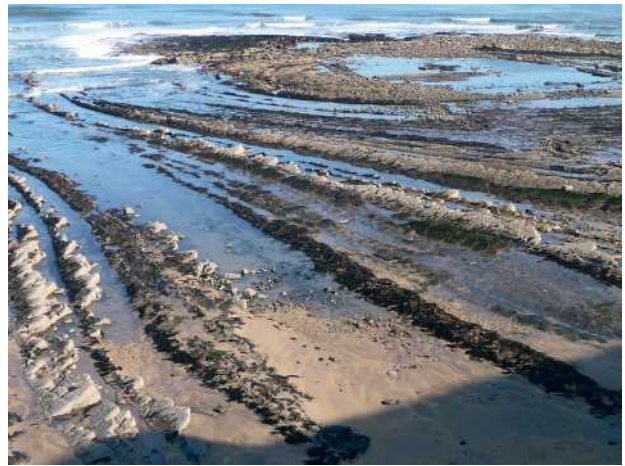
Figure 3.3: Limestones interbedded with sandstone, siltstone, and coal at Ladies Skerrs near Berwick-upon-Tweed, from the Alston Formation.

Limestones are commonly interbedded within the sandstones and siltstones of the central sector from rocks of the Stainmore, Alston, and Tyne Limestone Formations of the Carboniferous Period (Fig. 3.3). However, in the western sector the deposits from the Permian and Triassic Periods contain no limestones. For this part of the Wall, limestone would have had to have been transported from east to west. Indeed, there is evidence for this from a fragment of Carboniferous limestone during excavations at Cam Beck (Collins and Harrison 2023). There is a similar absence of limestones in the eastern sector where the Wall overlies the Pennine Coal Measures Formation. In this part of the Wall, the options would have been to transport limestone (or lime) from the west beyond Heddon-on-the-Wall or to bring it across the River Tyne from the extensive Permian Limestones to be found from Trow Rocks (near South Shields) and southwards.

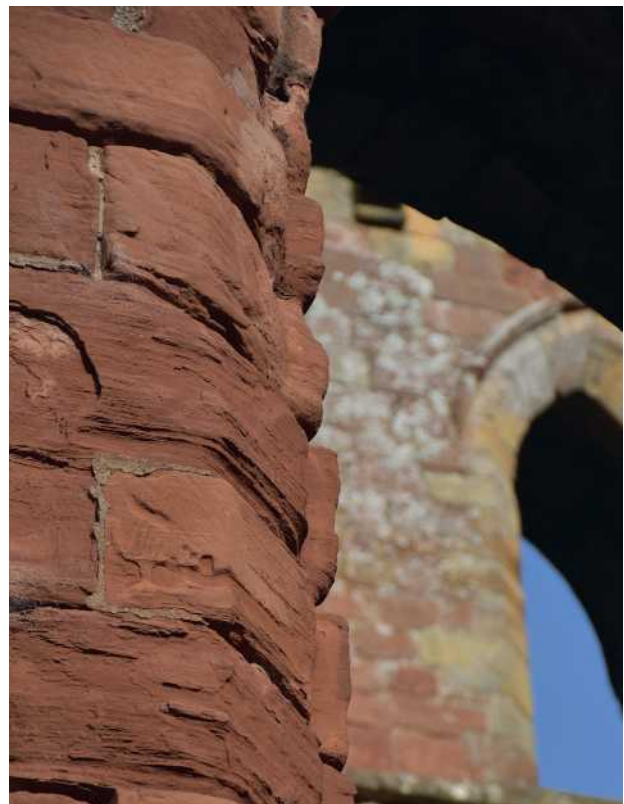
Figure 3.4: Weathered red sandstone of the St Bees formation at Lanercost Priory.

In general, the red sandstones of the Permian and Triassic tend to be softer and less durable than the Carboniferous sandstones. Casual examination of the gravestones in Walton Church graveyard and other locations show how readily the St Bees sandstone weathers (Fig. 3.4). Material recovered from the Cam Beck excavations was frequently so soft that it could be crumbled in the hand. However, stones in the extant Wall near Port Carlisle which also appear to be from the St Bees Sandstone Formation, based on their colour and sedimentary textures, have proven to be resistant to weathering. The Kirklington sandstone which may account for some of the material at Cam Beck is variable in its durability with nearby cliff sections crumbling in the hand. In contrast, the exposure of this sandstone at the base of the weir across the Cam Beck is highly durable.

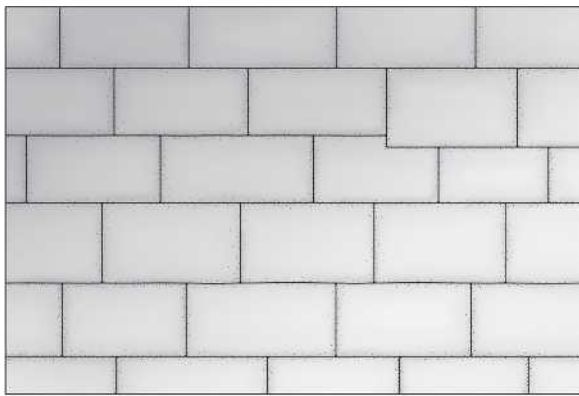
Ashlar

The rarest method for preparation of walling along Hadrian's Wall is ashlar, which requires carefully dressed stones that are finely jointed and bedded, to ensure a very clean and tight fit (Fig. 3.5A). As a method, it requires the greatest skill and quality of stone, and therefore can be seen as the most expensive relative to labour skill and time required (Fig. 3.7). It is worth noting that block-and-course and even squared rubble can sometimes be found in the literature described as ashlar, but these lack

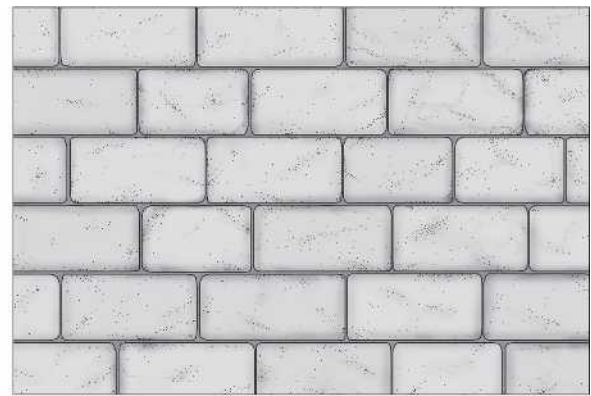
Perhaps the next most common technique found along the Wall is what is known as block-in-course. The technique requires larger dressed stones, blocks, which are squared to a reasonably good standard for stable, even coursing (Fig. 3.5B). The size of the stone blocks and their quality of finish allows them to sit tightly against each other, and the combination of proximity and mass together creates a solid and stable structure. The technique can be used with bonding material, though it is not required for the reasons outlined above. Block-in-course is typically found in positions where strength and stability is required, often in conjunction with a larger and/or weightier structure. For example, block-in-course is very typically observed in gate structures at milecastles and forts (Fig. 3.6), and at bridges. The technique is sometimes observed used for foundations and/or footings. It is frequently used in conjunction with squared rubble.

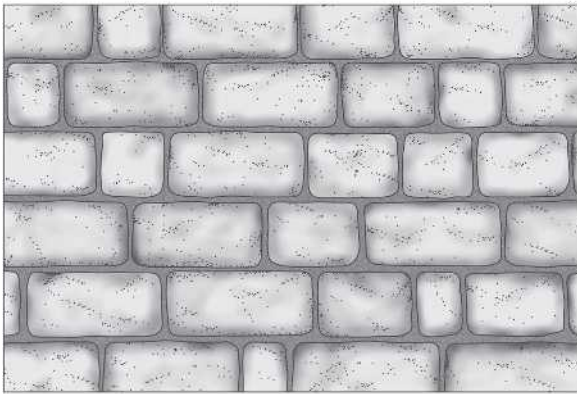
There are a number of ways in which stone can be dressed and prepared to build walling, and the requirements for building material can also influence methods of quarrying (Hill 2004, 43–46). The most commonly occurring building method found along Hadrian's Wall is squared rubble, a method used along the curtain, at turrets, milecastles, in forts, and most other structures (Fig. 3.5C). This consists of roughly dressed facing stones laid in courses, with mixed and/or unsorted materials used to fill the core between the outer faces of the wall. Individual stones are roughly (as opposed to carefully or precisely) dressed so that the outward face is subrectangular or subsquare, typically using the natural bedding of the geological material to determine the upper and lower beds or faces of the dressed stone. Note that the outer faces of the stones are not particularly well dressed, and can be uneven, or even undressed depending on the quality and natural cleaving properties of the rock selected. Squared rubble is deemed a relatively fast method of building, given that the stones can be dressed quite quickly and the squared shape of the stones allows for relatively easy coursing (Hill 2004, 46). It has been estimated that a person could achieve sufficient skill to 'square' rubble of quality sufficient for a Wall curtain facing stone with approximately an hour of training and supervision, after which skill would rapidly develop through lots of practice (P. Hill, pers. comm.) Bonding material is not essential for this technique, and there are lengths of Wall curtain that appear to never have been bonded, but good stability for squared rubble walling relies upon the strength of the bonding material (Hill 2004, 45–46). An unbonded length of Wall curtain built in squared rubble would be more

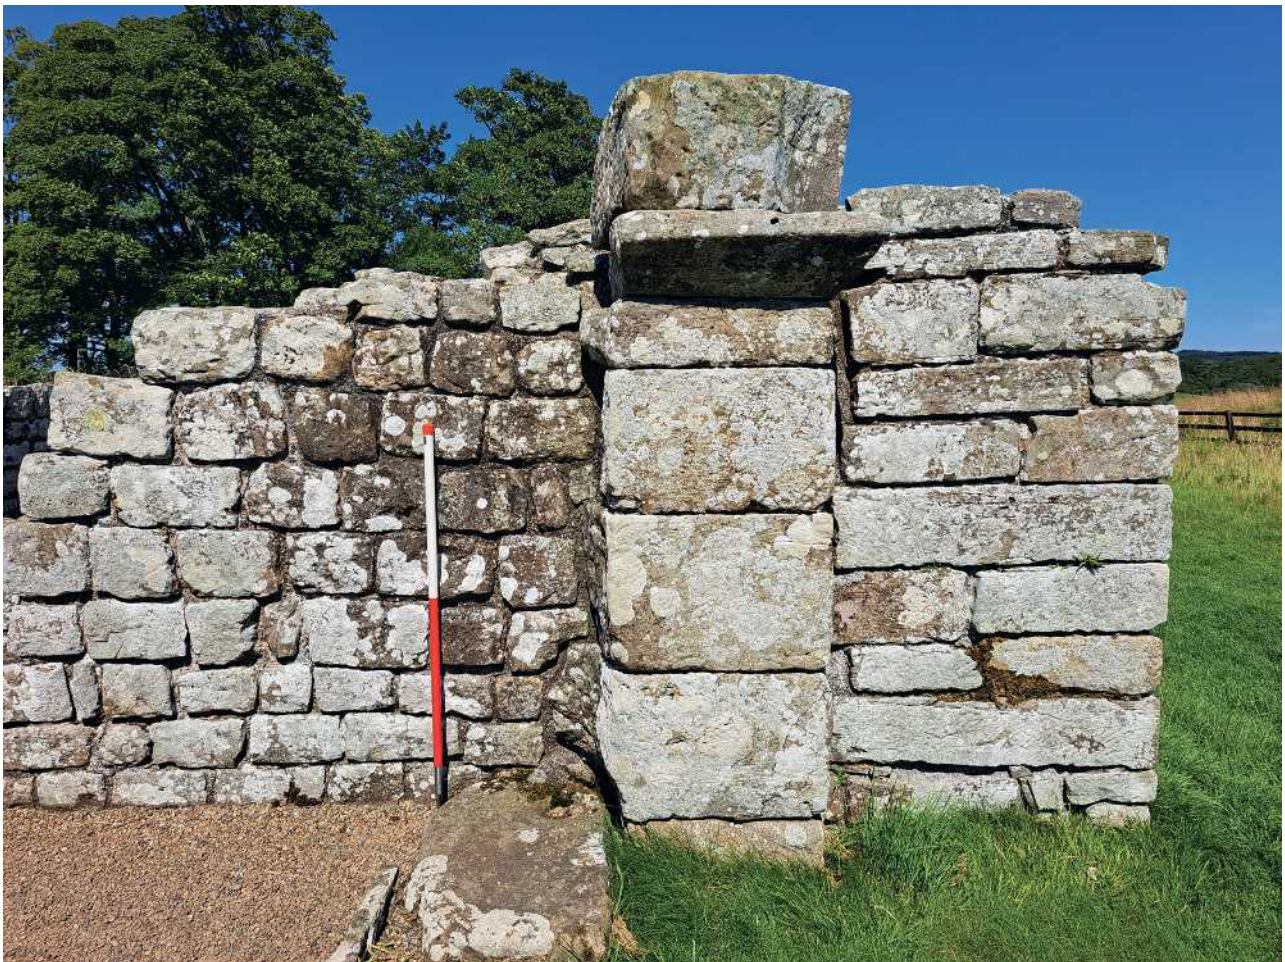
Figure 3.6: The north portal of the east gate at Birdoswald fort, showing the use of block-in-course construction for the outer fort walling and gate pier (right) while squared rubble is used for the internal gate walling (left). Scale bar is 1 m.

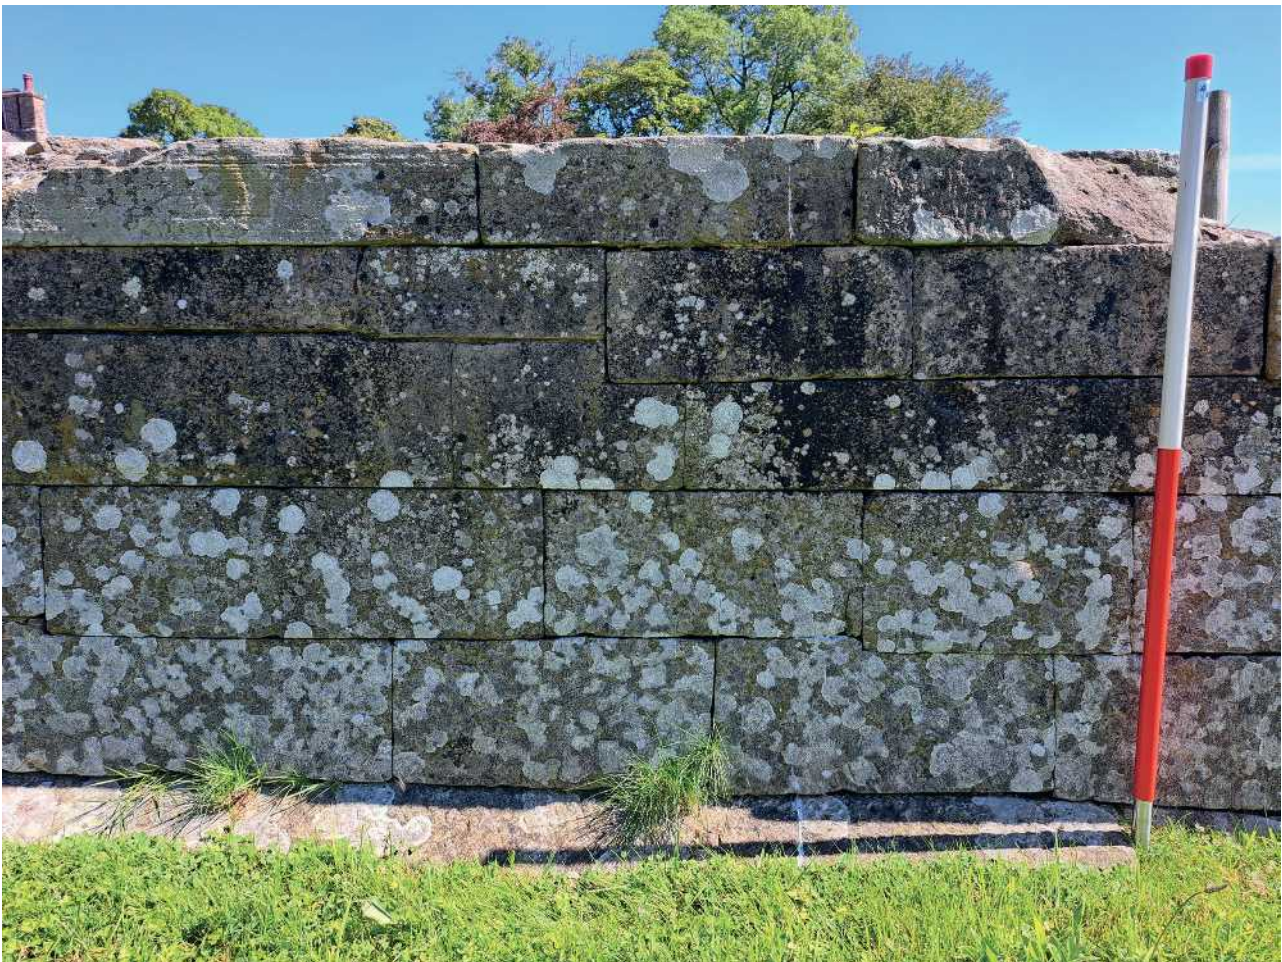
Figure 3.7: Ashlar used at the east gate of Birdoswald fort. Note the high-quality finish to the faces, beds, and joints of each stone, ensuring a tight fit. Scale bar is 1 m.

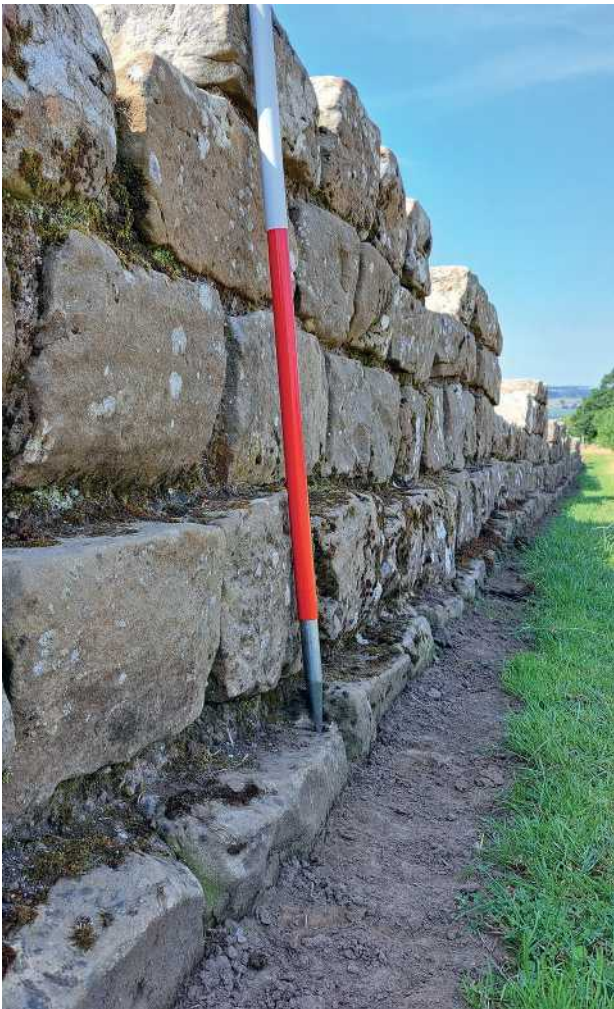
Figure 3.9: The north face of the curtain at Planetrees, with first course over the foundations providing a single-footing. Scale bar (red section) is 50 cm.

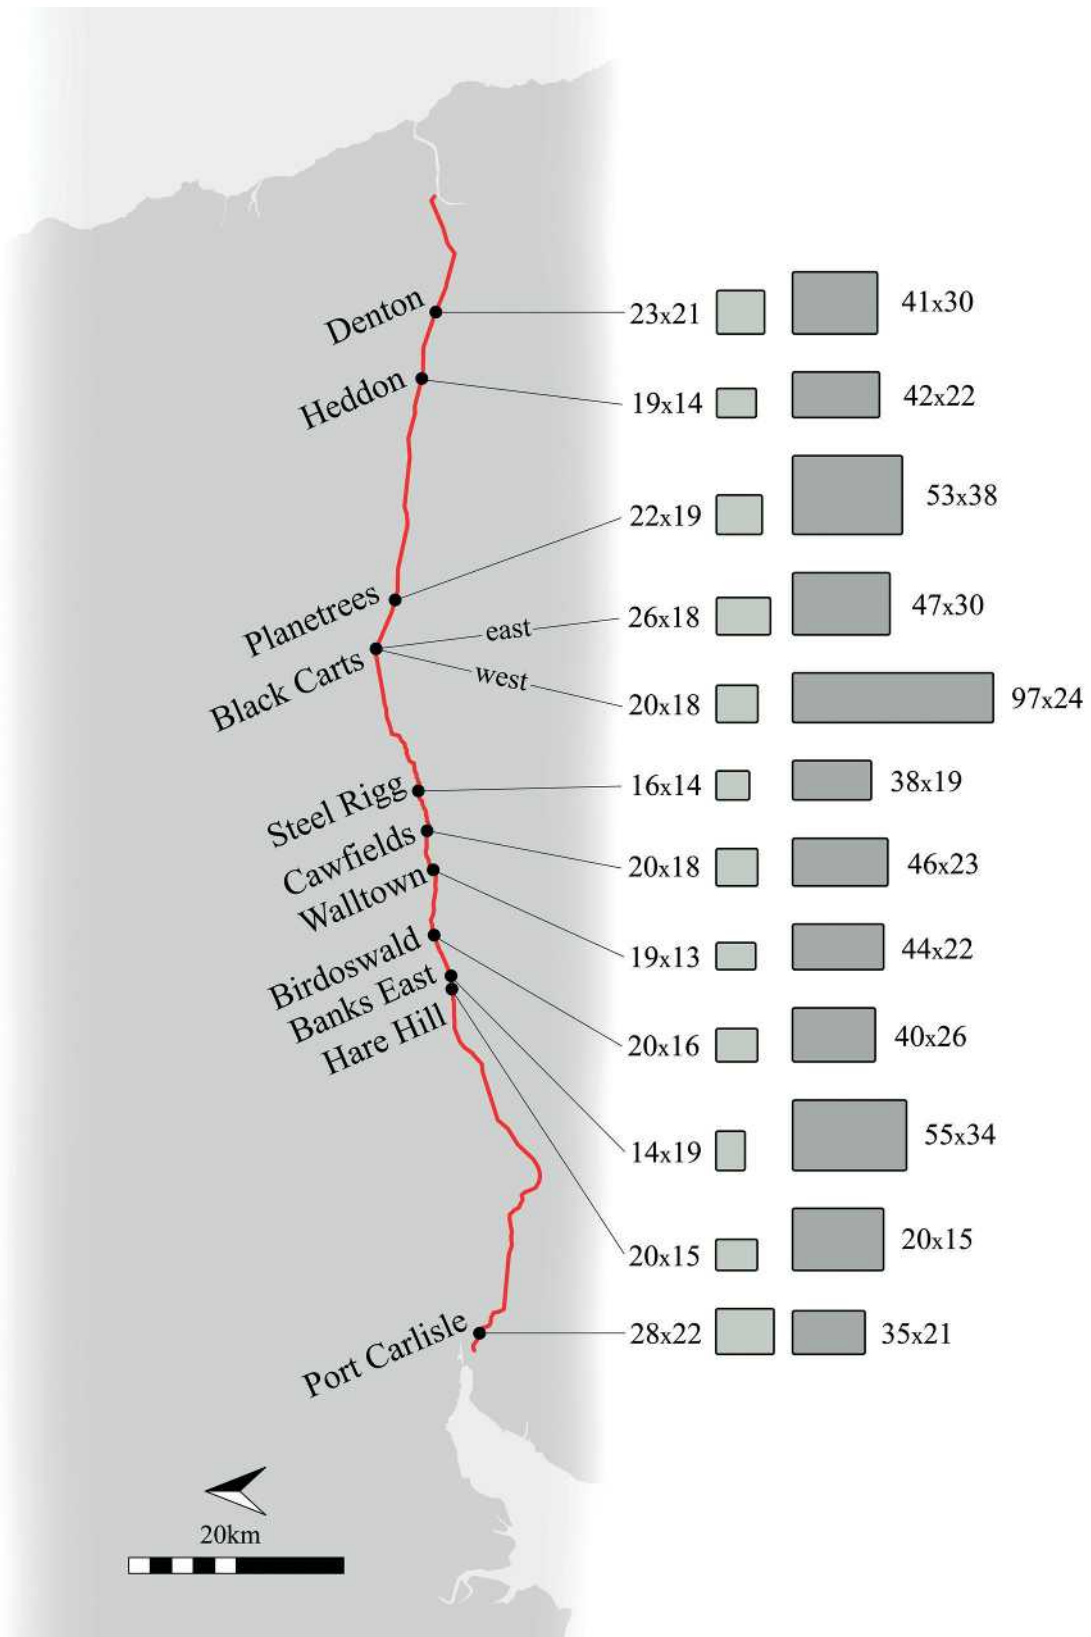
Figure 3.10: The range of stone sizes, from typically smallest to typically largest, visualised by location along Hadrian's Wall. Illustration by Matilde Grimaldi.

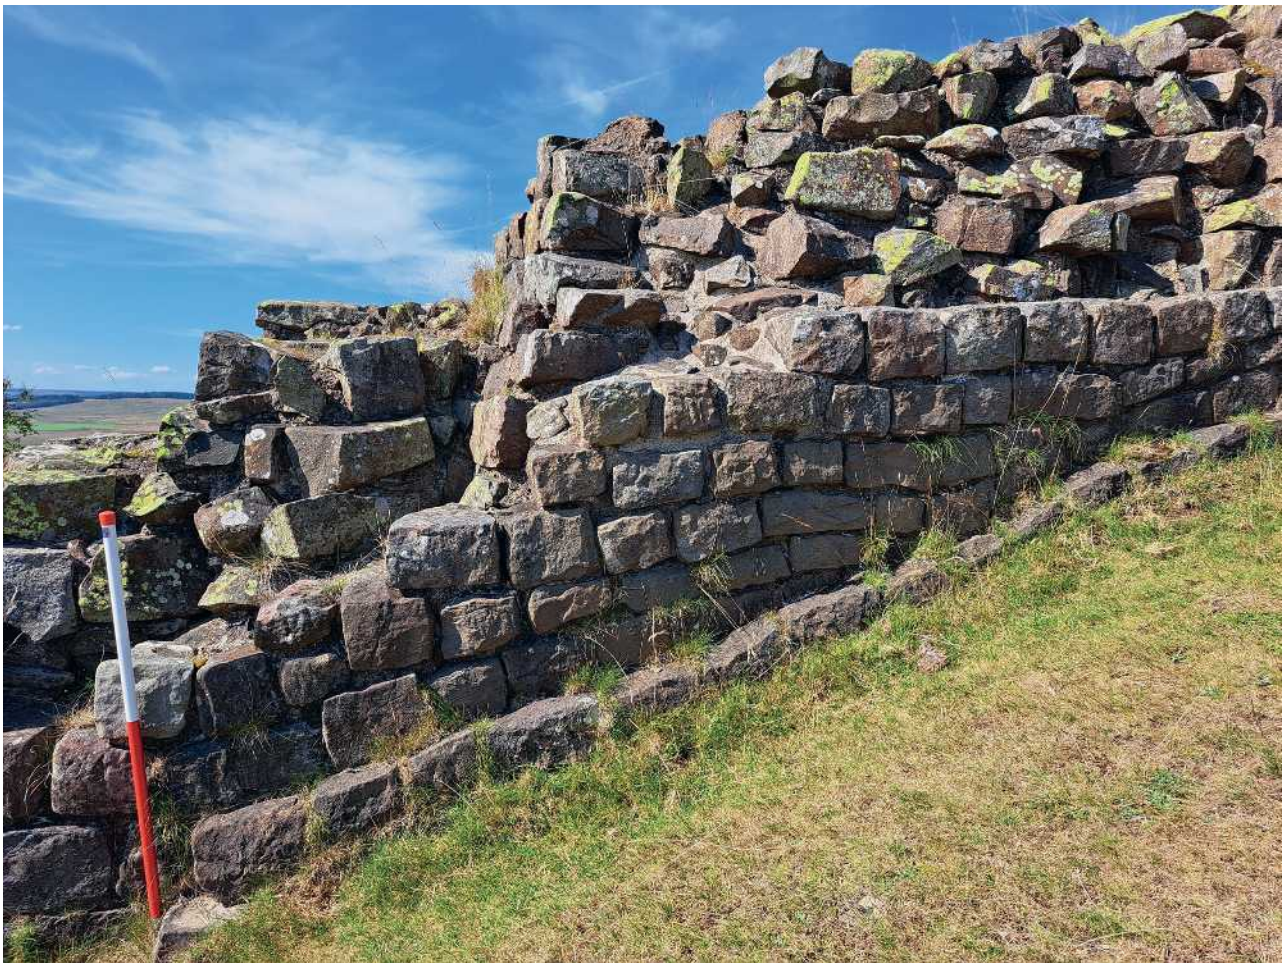
Figure 3.12: The south face of the curtain at Walltown Crags, where it runs down a slope to the west. Note how the foundation stones generally parallel the slope of the ground, while the stone courses above mix sloped coursing and even coursing, rather than stepped coursing that cuts into the slope. The scale bar is 1 m.

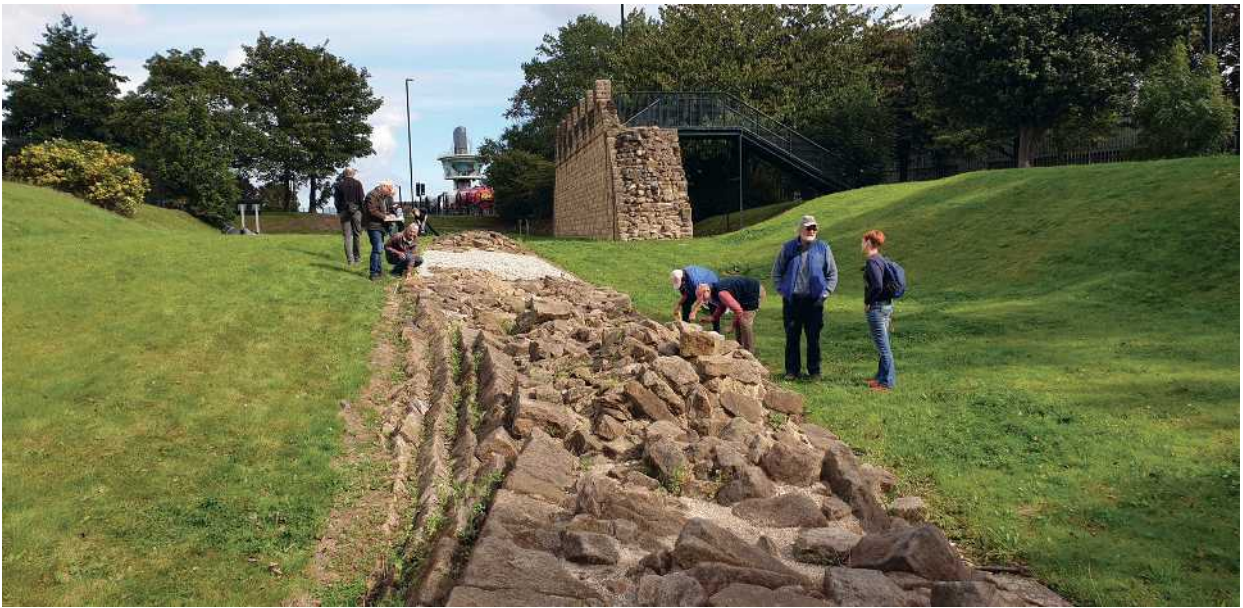
Figure 3.14: The consolidated length of Wall curtain at Buddle Street, Wallsend, which had multiple phases of collapse and reconstruction. Collapses introduced curves into the normally straight curtain, which were incorporated into rebuilds.

used. The course of the curtain also preserves slight bends or curves instigated by episodes of collapse (Fig. 3.14). However, silt deposits containing Roman ceramics of the later 4th century indicate that the curtain was standing until at least the end of the Roman period.
