FABRIC *of the* FRONTIER

*Prospection, Use, and Re-Use of Stone
from Hadrian's Wall*

Rob Collins, Ian Kille & Kathleen O'Donnell

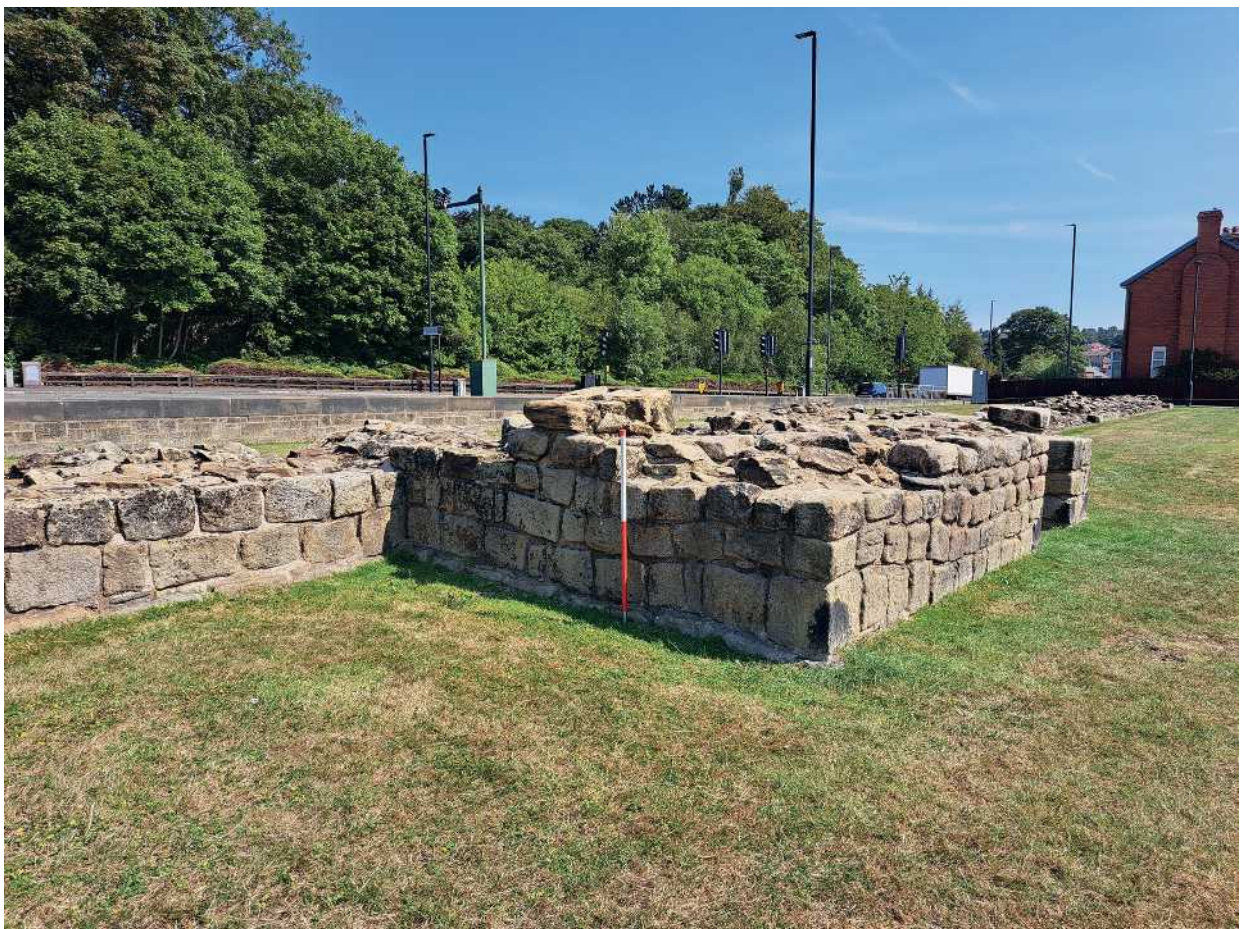
Figure 3.15: Denton turret 7b, as viewed from the southwest. Note how the southern and western external faces have been consolidated, fixing the slump of coursing. The larger stones visible in the southwest and southeast corners and the south face of the curtain are in situ Hadrianic fabric, while the smaller stones that make up the south and west turret faces are rebuilt. The scale bar is 1 m.

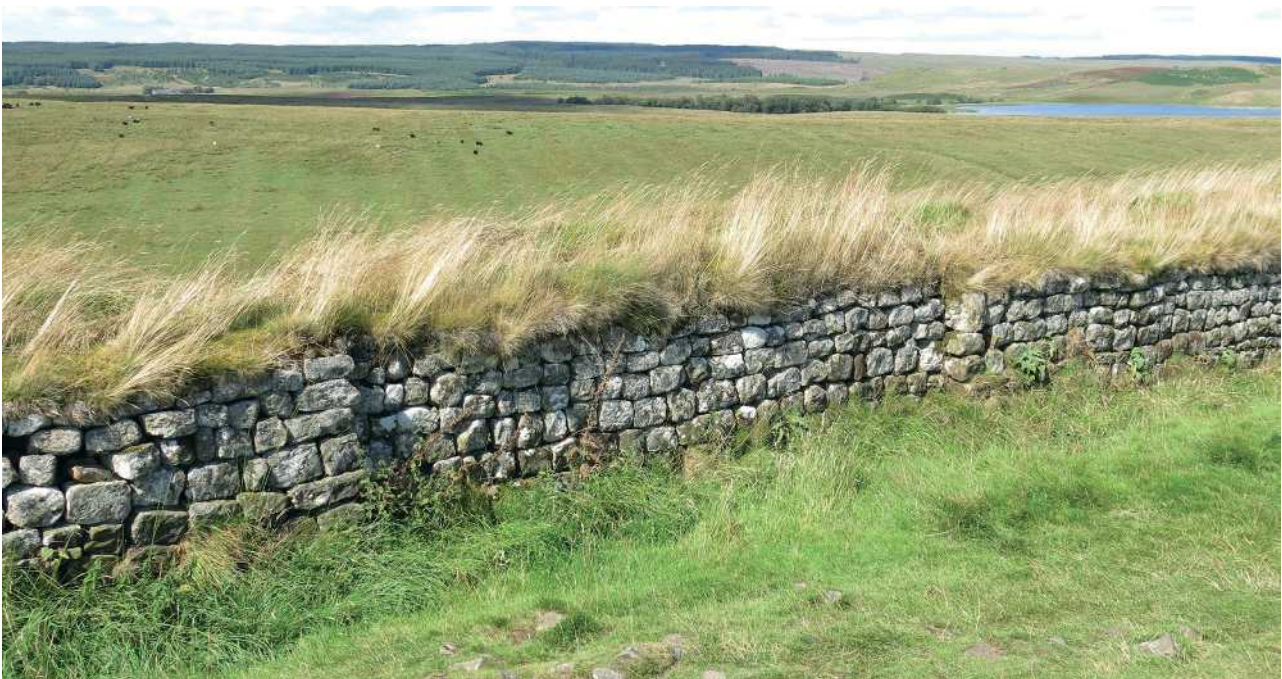
Figure 3.16: Projecting offsets visible on the south face of the Wall curtain in Wallmile 37, west of Housesteads fort. This location has two offsets in close proximity with a slightly narrower length of curtain between them.

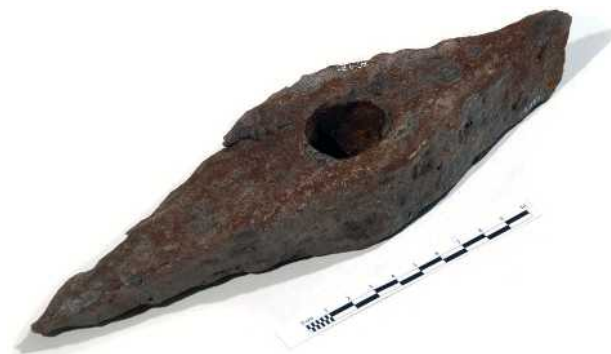
Figure 4.3: CO114, mason's pick from Corbridge. © English Heritage.

Tools used in the quarrying process have been found at Hadrian's Wall and around the empire (Pearson 2006, 53). Tools found at the Wall include axes, chisels, hammers, picks, and iron wedges (Breeze 2006, 91). Figures 4.2 and 4.3 show a chisel and pick found at Corbridge. Thanks to the recovery of these items, we have a good understanding of which tools performed which purposes in the stone extraction process. Good descriptions of the tools used in stone cutting, and what functions they performed, can be found across multiple works (Blagg 1976; Dworakowska 1983; Manning 1985; Shirley 2001; Hill 2004; Pearson 2006; Wootton *et al.* 2013). Quarry picks, axes, and adzes would have been used by the masons and

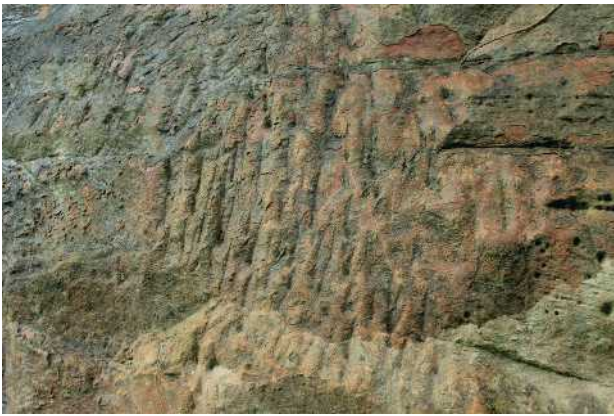
Figure 4.4: Pointed chisel marks at the Gelt quarries, Cumbria.

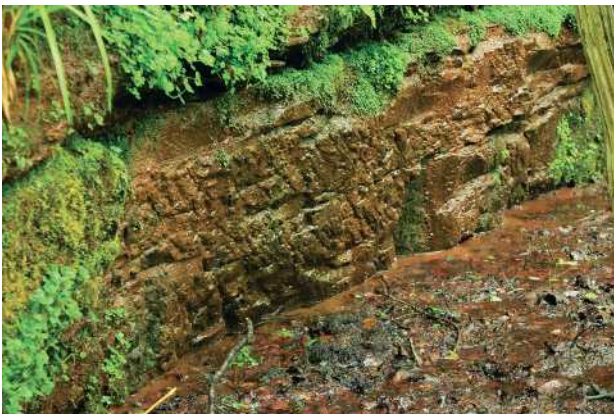
Figure 4.5: Water-worn pointed chisel marks at the Gelt quarries, Cumbria.

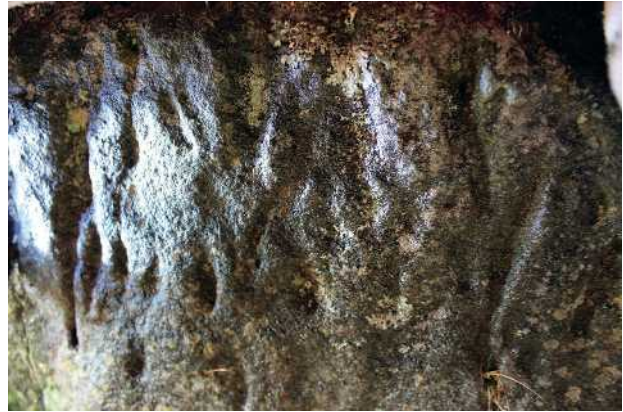
Figure 4.6: Natural weathering on limestone at a quarry on Barcombe Hill, Northumberland.

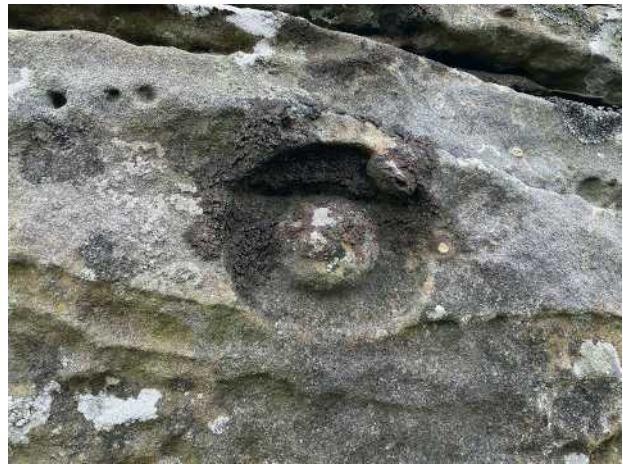
Figure 4.7: Ring-shaped mark possibly caused by iron concretion at Dove Crag, Northumberland.

a result of water erosion and weathering. Figure 4.7 shows a ring-shaped mark on an outcrop near Dove Crag which may have been caused by a concretion in the sandstone which has eroded away, and Figure 4.8 shows the regular

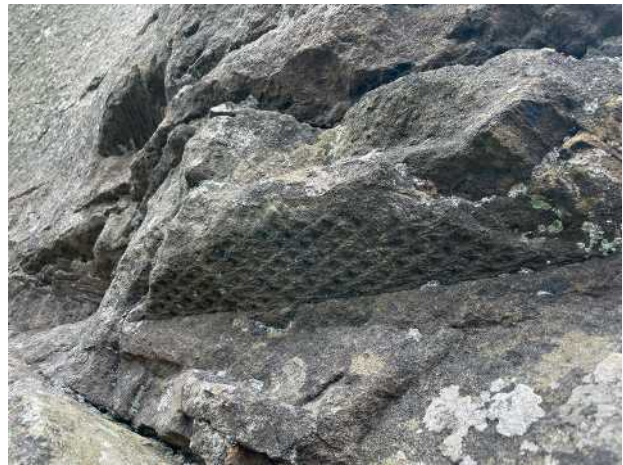
Figure 4.8: Cast of tree bark on sandstone outcrop near King's Crag, Northumberland.

geometric pattern left behind by a cast of *Lepidodendron*, a large carboniferous tree species with diamond shaped scales on its trunk. Identifying archaeological evidence of quarrying is best done in close collaboration with specialists in geology to make sure accurate distinctions are made between natural and archaeological processes.

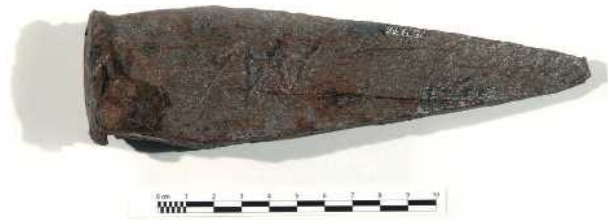
Figure 4.9: CO111, iron wedge from Corbridge. © English Heritage.

Wedges are a tool used in the stone quarrying process to split the stone. Wedges made from iron or wood would be placed into cut wedge holes along natural bedding lines in the stone (see Fig. 4.9). Iron wedges would be hammered in to cause the stone to split, and wooden wedges would be soaked in water, which causes them to expand and break the stone (Wootton *et al.* 2013, 3).

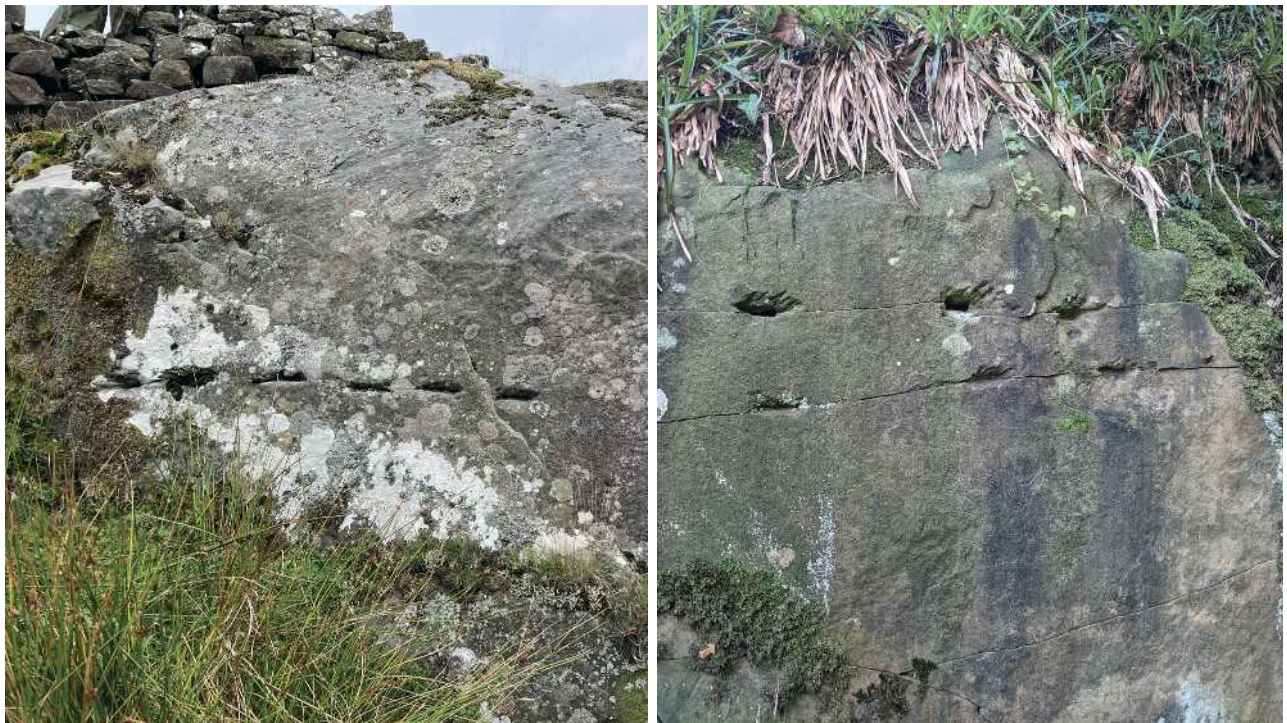
Figure 4.10: Left image – line of wedge holes at *Queen's Crag quarry, Northumberland*; right image – wedge holes with visible toolmarks at *Comb Crag quarry, Cumbria*.

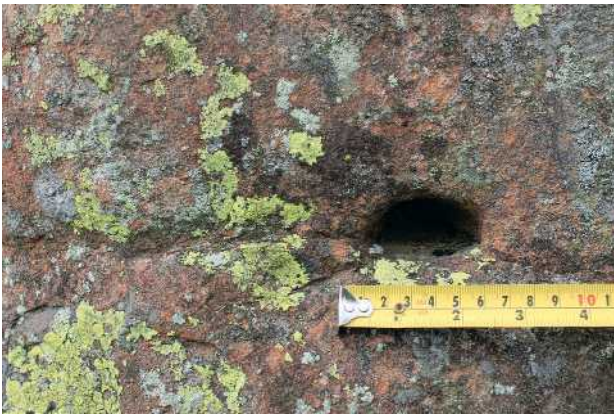
Figure 4.11: Wedge hole in whinstone near Walltown Crags, Northumberland.

sandstone, limestone, and dolerite, and variations in each of these are visible mainly due to differences in the way each stone weathers. Wedge holes can also be identified on blocks that have already been removed from the quarry face where they have been used to split open the stone (see Figs 4.10, 4.11 and 4.12). Wedge holes in whinstone seem to be more rounded and deeper, compared to the long thin wedge holes seen at the sandstone quarries. Additionally, in some of the modern limestone quarries wedge holes have been placed vertically through the stone, perpendicular to the grain instead of parallel to it. This can also be seen at the Roman quarry on Barcombe Hill, where a series of three wedge holes run vertically down the sandstone quarry face, but this was to take advantage of a natural fissure in the rock (Blagg 1976, 154).

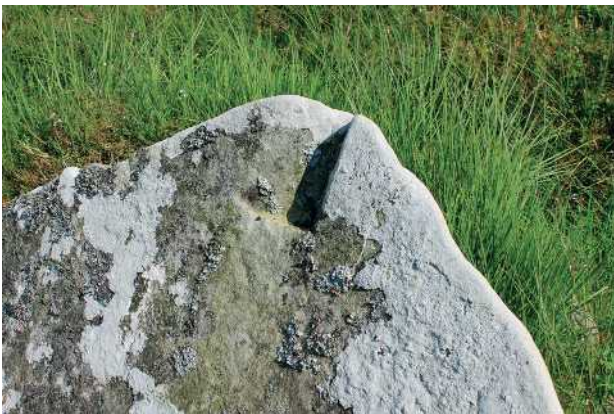
Figure 4.12: Half wedge hole left on block following removal at small outcrop near Housesteads fort, Northumberland.

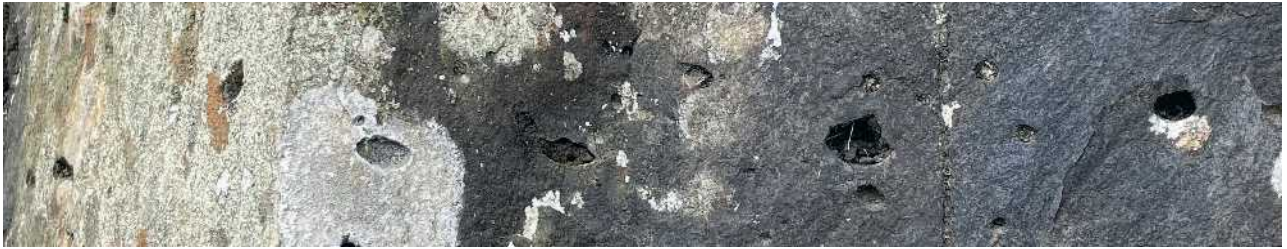
Figure 4.14: Vesicles in whinstone at Cawfields Quarry, Northumberland.

in bubbles. As it cools, these bubbles become set into openings called vesicles. These bubbles leave cavities in the natural stone which when weathered can be mistaken for man-made holes (Fig. 4.14). In sandstones rip-up clasts of mud-flakes are deposited when storm follows drought and dried out mud is washed out and deposited in layers

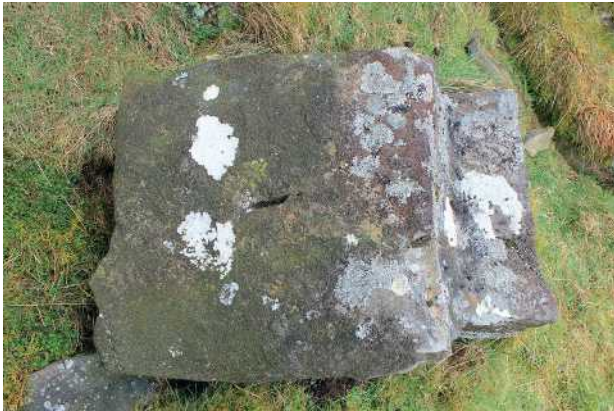
Figure 4.15: Large removed and partially shaped stone block at a quarry near Crag House, Northumberland.

Cut stone blocks are a very useful type of evidence which can be used to distinguish between natural outcrops and stone which has been quarried. The removal of large blocks of stone leaves noticeable rectilinear negative spaces on the quarry face and these are often removed in a regular repeating pattern. The cutting of stone blocks can also create terracing within the quarry or a zigzag-shaped pattern in the quarry face which can be observed through aerial photography. The removed stones vary from small, irregular shaped blocks to much larger ones, 2–3 m in length. As a large proportion of the stones used to construct Hadrian's Wall were either small facing stones or rough core rubble, the block removal patterns are not as regular and 'organised' as one can observe in Roman quarries in other parts of the Empire (see the regular limestone block removal in Egyptian Roman period quarries – Harrell and Storemyr 2013, 35). This is also impacted by the very variable thickness of sandstone beds available in the local geological landscape. Figures 4.15 and 4.16 show examples of removed blocks.

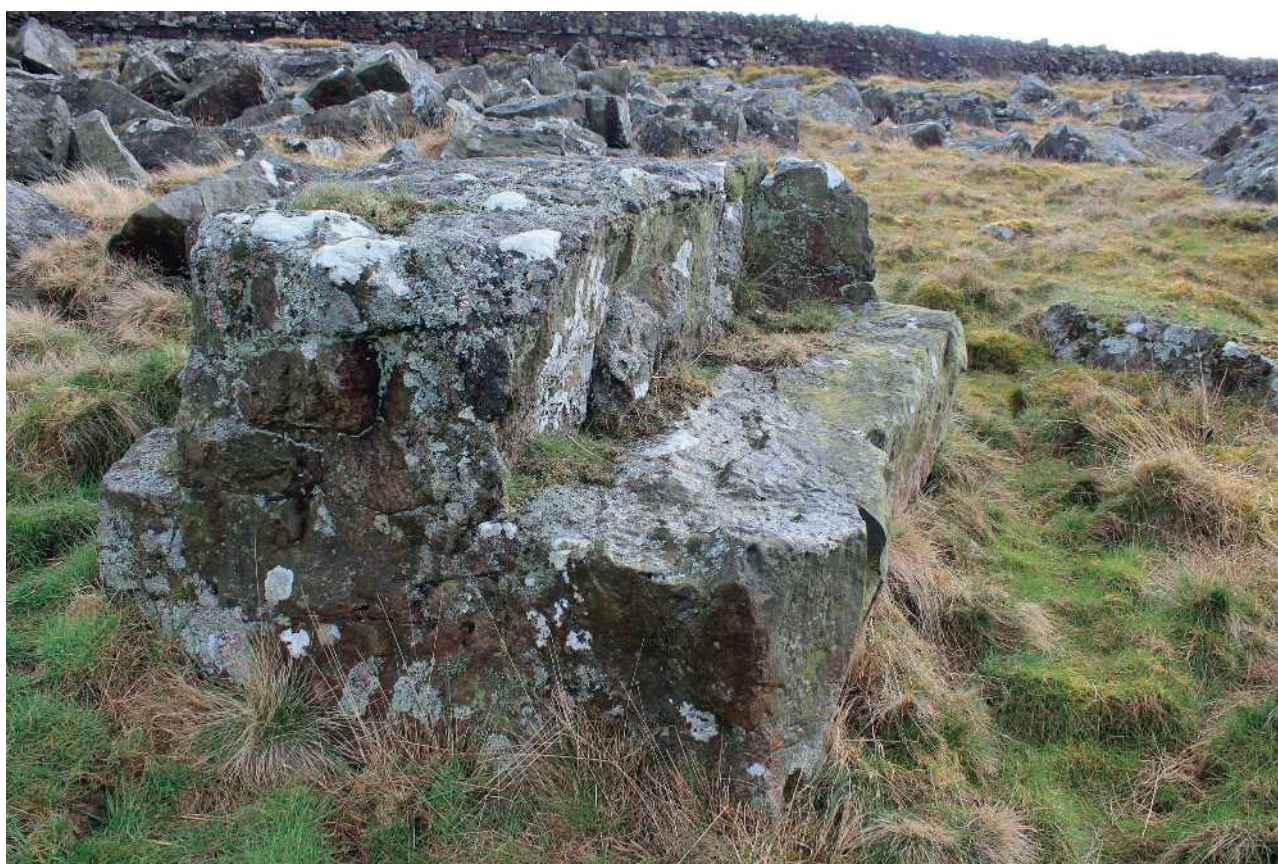
Figure 4.16: Removed block and spoil heap at a blasted quarry on Thorngraston Common, Northumberland.

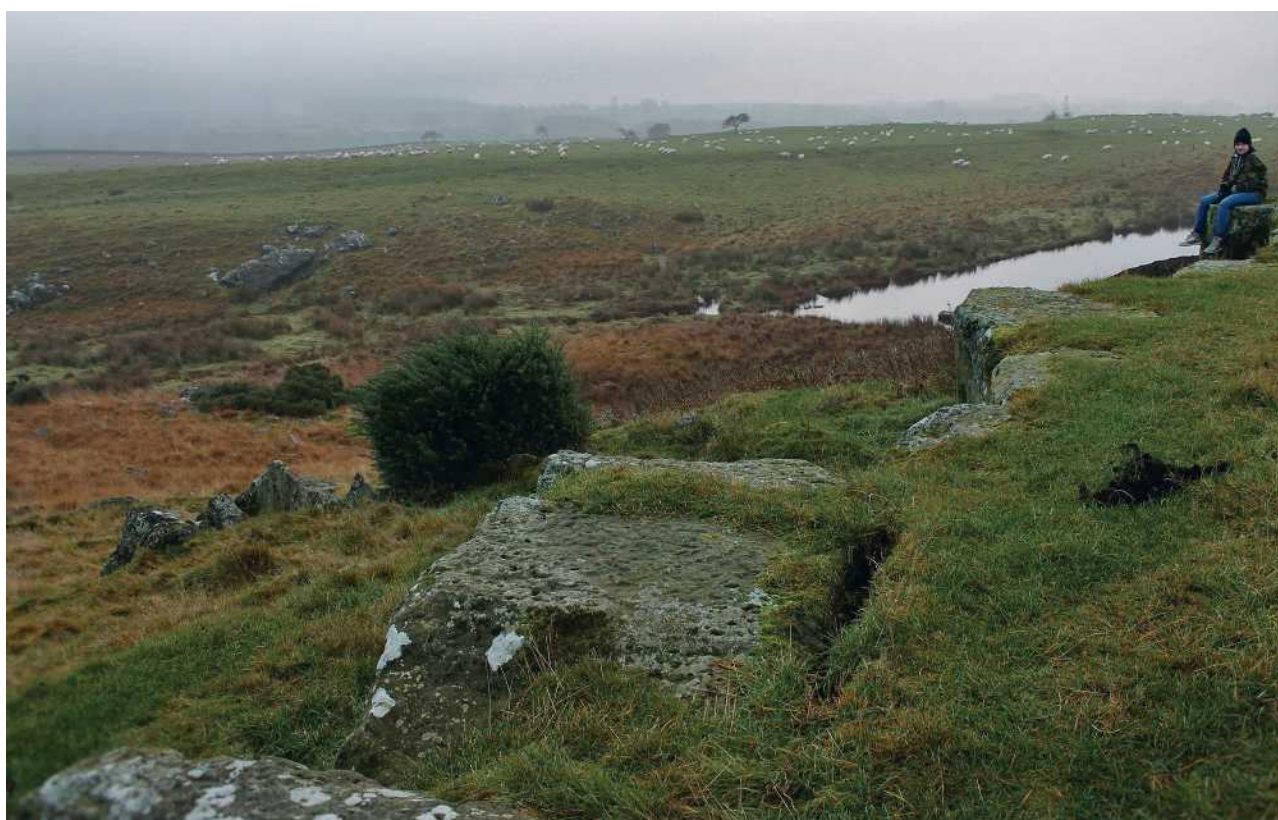
Figure 4.17: Partially removed block at Fallowfield Fell Quarry, Northumberland.

The stone is medium grained and pale grey in colour. Chiselled channels marking out blocks to be removed, and partially cut blocks are still visible along the face (Fig. 4.17). Much like Comb Crag, this quarry is close to Hadrian's Wall, *c.* 700 m, and the terrain consists of gentle slopes where the bedrock lies very close to the surface. The shallow bedrock in the area causes rapid flooding in low-lying areas during heavy rain so the construction of a road for stone transportation may have been required to avoid becoming bogged down in the mud. A potential road between the quarry and the Wall was identified which leads southwest–northeast away from the quarry until it is covered by a tree-line. The 'road' can be seen clearly in satellite imagery and in person at ground level (Fig. 4.30). The linear feature is erroneously listed on *Keys to the Past* (ref. N8594) as part of the Vallum of Hadrian's Wall. The date of the road is unknown and it may be a medieval trackway or other pre-modern feature.

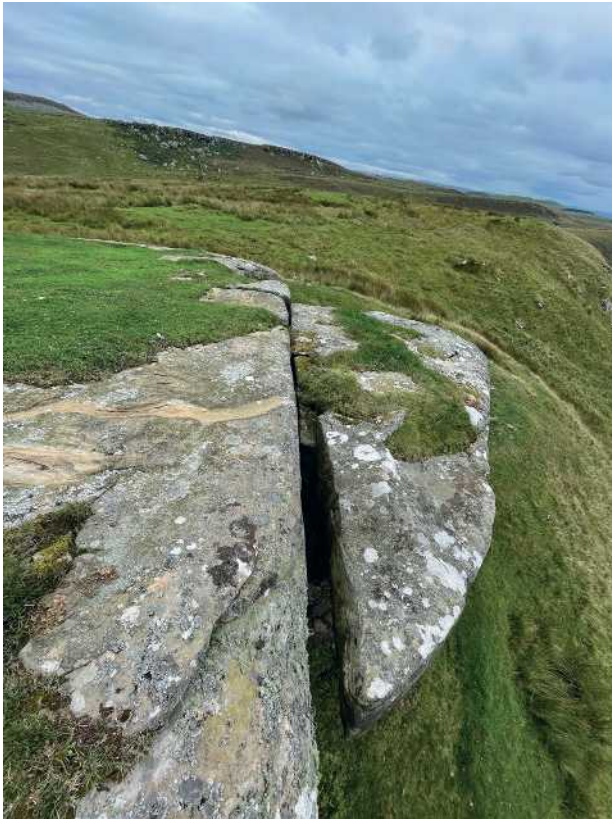
Figure 4.18: Linear cracks in weathered stone.

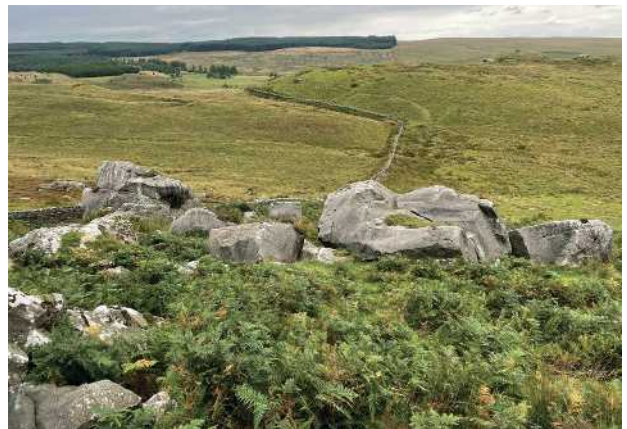
Figure 4.20: Spoil heap covered by vegetation at Queen's Crag, Northumberland.

the stone which creates a lot of waste. The hardness of the limestone in these quarries has prevented them from weathering as quickly as the softer sandstones in the Roman quarries. The spoil heaps at the Roman quarries are often overgrown and covered with vegetation, and the continued deterioration of the quarry faces mean new rubble is regularly deposited on top of the original debris from the Roman period (Fig. 4.20).

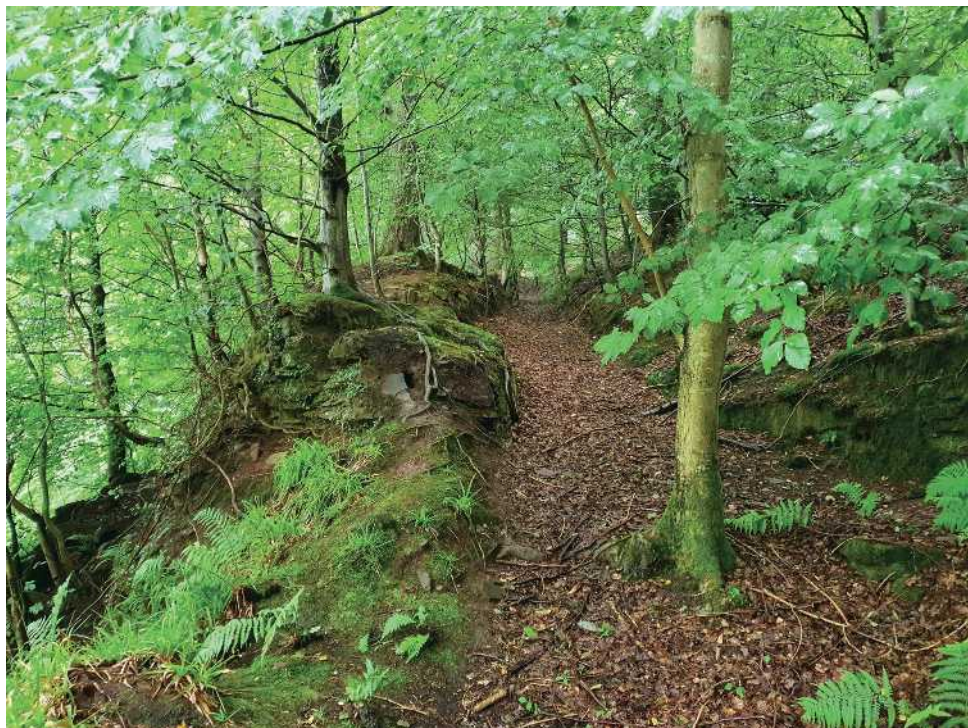
Figure 4.21: Possible cart path on the west bank of the River Gelt, Cumbria.

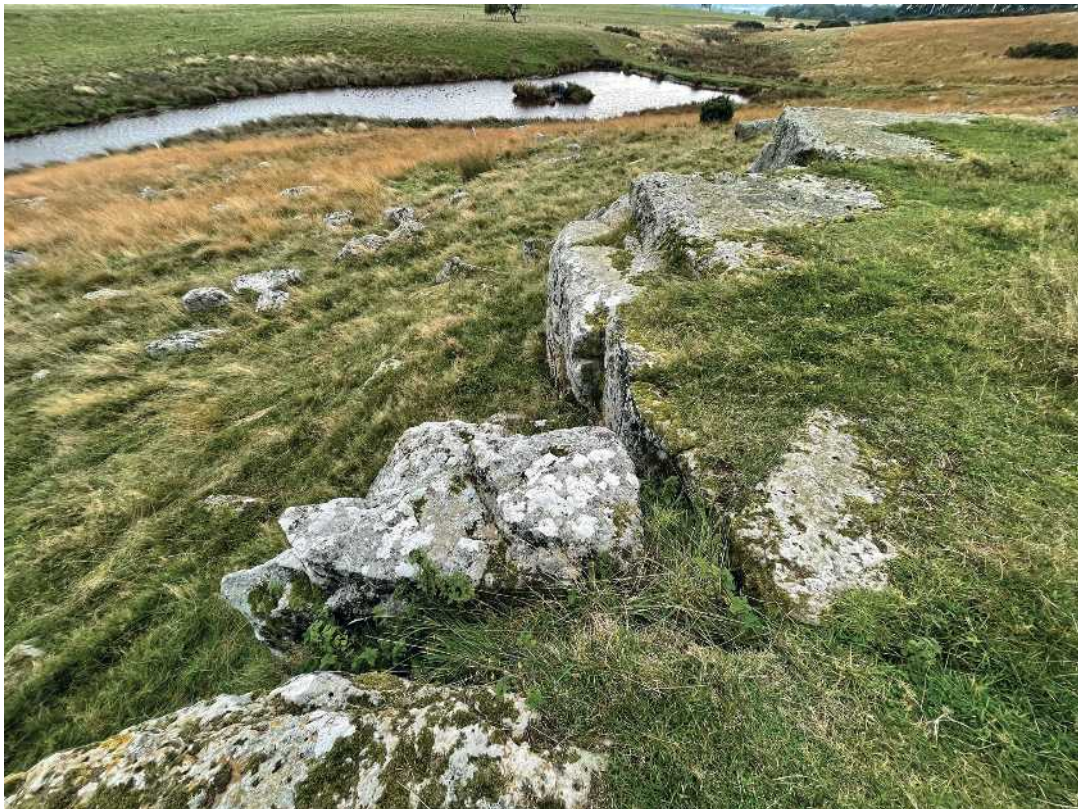
Figure 4.25: The stepped pattern of block removal partially visible under overgrowth at Fallowfield Fell, Northumberland.

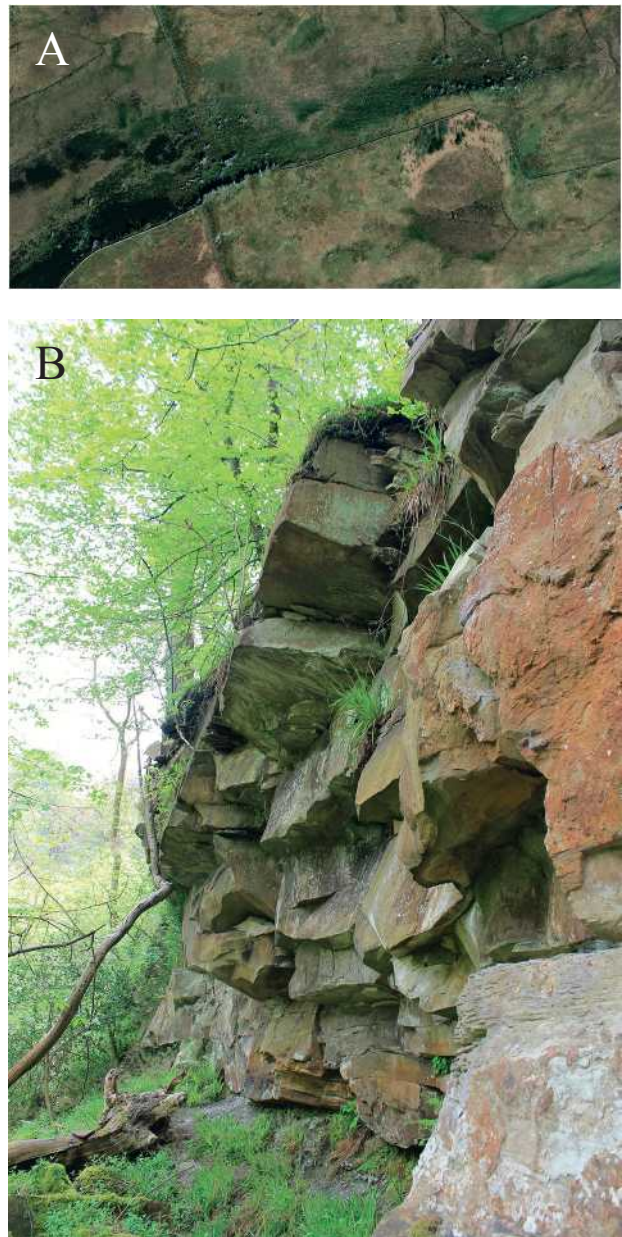
Figure 4.27: (A) Satellite imagery of the quarry face at Queen's Crag. © Apple Maps. (B) The overhanging rock on the quarry face at Comb Crag, Cumbria.

Crag Wood. The faces of these quarries vary in length but have a higher face (2 m+) which necessitates extracting blocks vertically before stepping back further into the stone. Similar to shallow-faced quarries, Roman quarrymen extracted uniformly sized large blocks from the face before moving them away to break down and rework. The zigzag pattern in the quarry faces can be seen from above (Fig. 4.27a).

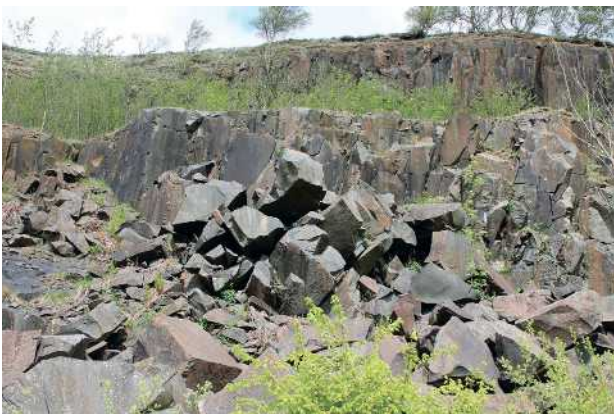
Figure 4.28: Angular rubble as a result of blasting at Cawfields Quarry.

There are a number of other quarry types in the Wall corridor which can be seen but are either exclusively modern and therefore not considered to be Roman stone sources, or they cannot confidently be ascribed a date. Backfilled quarries are very visible on satellite imagery but very difficult to identify at ground level. These have usually been opened for a short time and backfilled as they are on farmland. Backfilling has been mentioned in accounts from the construction of the military road (B6318) to cover up small quarry pits used by the army with permission from the landowner (Lawson 1971, 35, 69; 1973). Blasting can also be seen at the modern whinstone quarries at Cawfields and Walltown (Fig. 4.28). These are much larger in proportion than the ancient quarries and leave huge irregular rubble behind due to the blasting process.

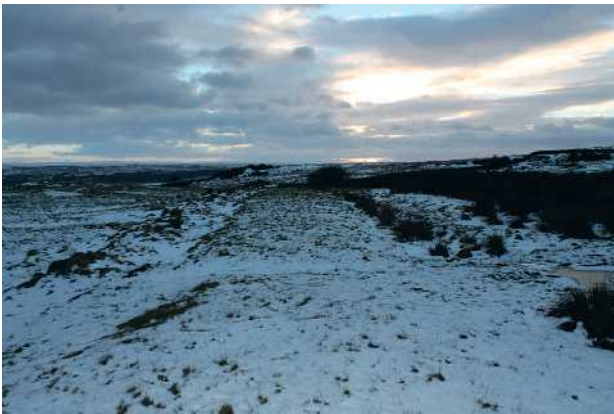
Figure 4.30: A road feature near Fallowfield Fell quarry, Northumberland, that may be a trackway associated with the Roman quarry. There is no conclusive dating evidence associated with it.

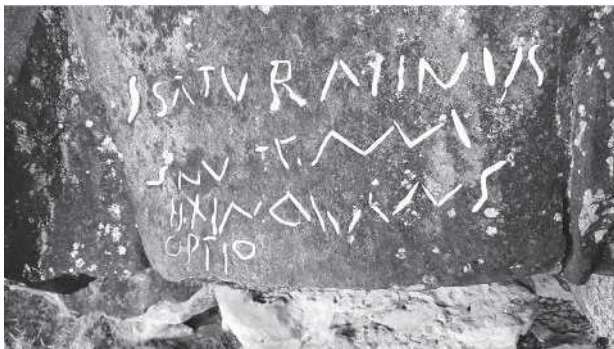
Figure 4.33: RIB 3331 at Queen's Crag, Northumberland, with the photo taken by K. O'Donnell and the inscription overlain with white to increase visibility.

The inscription on the quarry (RIB 3331) was discovered carved under a large overhanging rock near the Black Dyke in 1960 (Fig. 4.33):

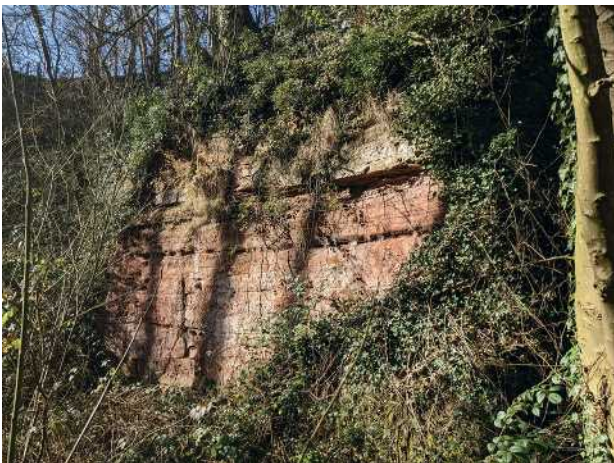
Figure 4.35: The face of a Roman quarry at Shawk.

Three inscriptions have been recorded at the Roman quarry at Shawk, none of which survive today (RIB 1001–1003). Despite the missing inscriptions, evidence of quarrying can still be seen in the area. Shawk (or Shalk or Chalk) is similar in form to Gelt with a series of quarries excavated into the bank of the incised stream, the Chalk Beck. This quarry was not archaeologically investigated by WallCAP or in the work by O'Donnell

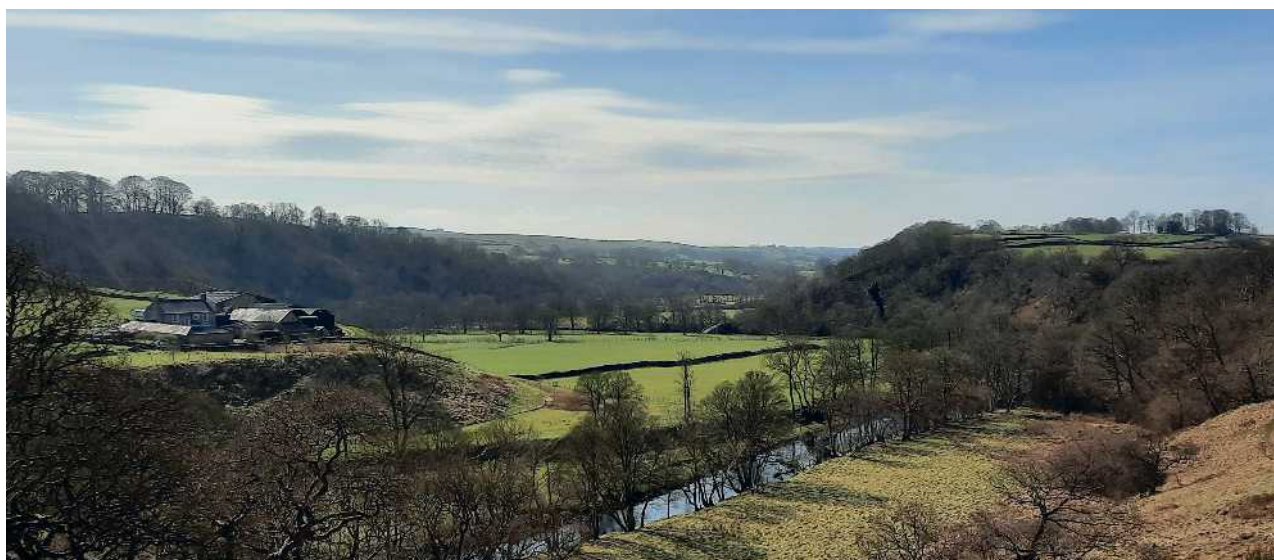
Figure 5.1: Willowford Farm, at the left side of the photo, is located directly on the line of the Wall curtain. The Wall can be seen running west across the photo, up the slope at Harrow's Scar and continuing to the fort at Birdoswald, marked by the trees and buildings on the horizon at the right side of the photo.

In many, perhaps even the majority of instances, inscription and sculpture is incorporated into structures local to the original findspot of the stone. For example, at Willowford Farm, built directly on the line of the curtain to the west of turret 48b (Fig. 5.1), there are 12 stones registered in RIB as from the farm, or perhaps close by (Table 5.1). Of these 12, at least 9 were built into the farmhouse or other structures related to the farm. There are a range of stones, not all of which could be identified for their function, but include centurial stones that would have originally been incorporated into the south face of the curtain, and a number of altars that probably originated from the fort at Birdoswald, approximately 1 km

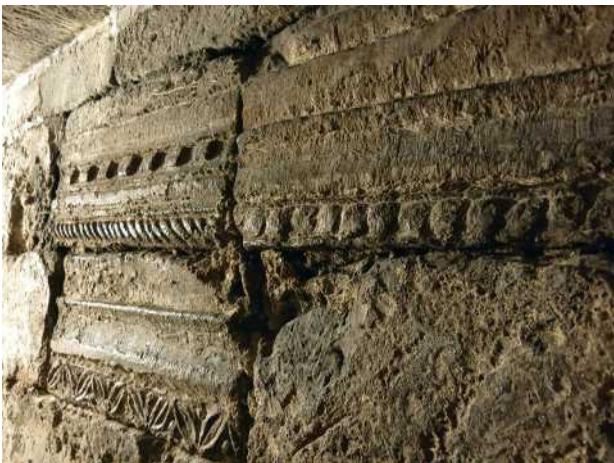
Figure 5.5: Decorated Roman stone blocks in the 7th-century crypt at Hexham Abbey, re-used from Roman buildings at Corbridge.

It has long been recognised that many post-Roman structures have incorporated Roman stones and architectural features. In the early medieval period alone, the crypt at Hexham Abbey makes extensive use of decorated Roman blocks, inscriptions, and friezes, while St Andrew's church, Corbridge, incorporated an entire Roman arch to separate the nave from the tower (Fig. 6.1); both sites seemed to have sourced fabric from the Roman town at Corbridge, and possibly other locations. At St Paul's, Jarrow, window-heads and doorways were some of the architectural stonework repurposed from the forts at Wallsend and/or South Shields (Fig. 6.2). Nor is such use of stone limited only to the decorated or more functionally complex fabric. Facing stone is also regularly repurposed from the Wall. In the early medieval period, the majority of repurposed Roman fabric tended to be associated with Christian buildings, and alongside the more practical labour-saving measures of recycling the fabric, explicit use of Roman stone also carries ideological claims. For example, access to the stone is likely to have been granted through elite secular (royal) permission or grants, highlighting the privileged position of the church vis-à-vis secular authorities; such use may have also underpinned claims of the *romanitas* of the Christian church in the absence of the now fallen Roman Empire, and its inheritance of Roman authority seen across the former Western Empire; the conspicuous use of stone for new monumental construction also implies an expectation of permanency in the landscape (Leone 2007; Turner *et al.* 2013, 158–159, Fafinski 2021).

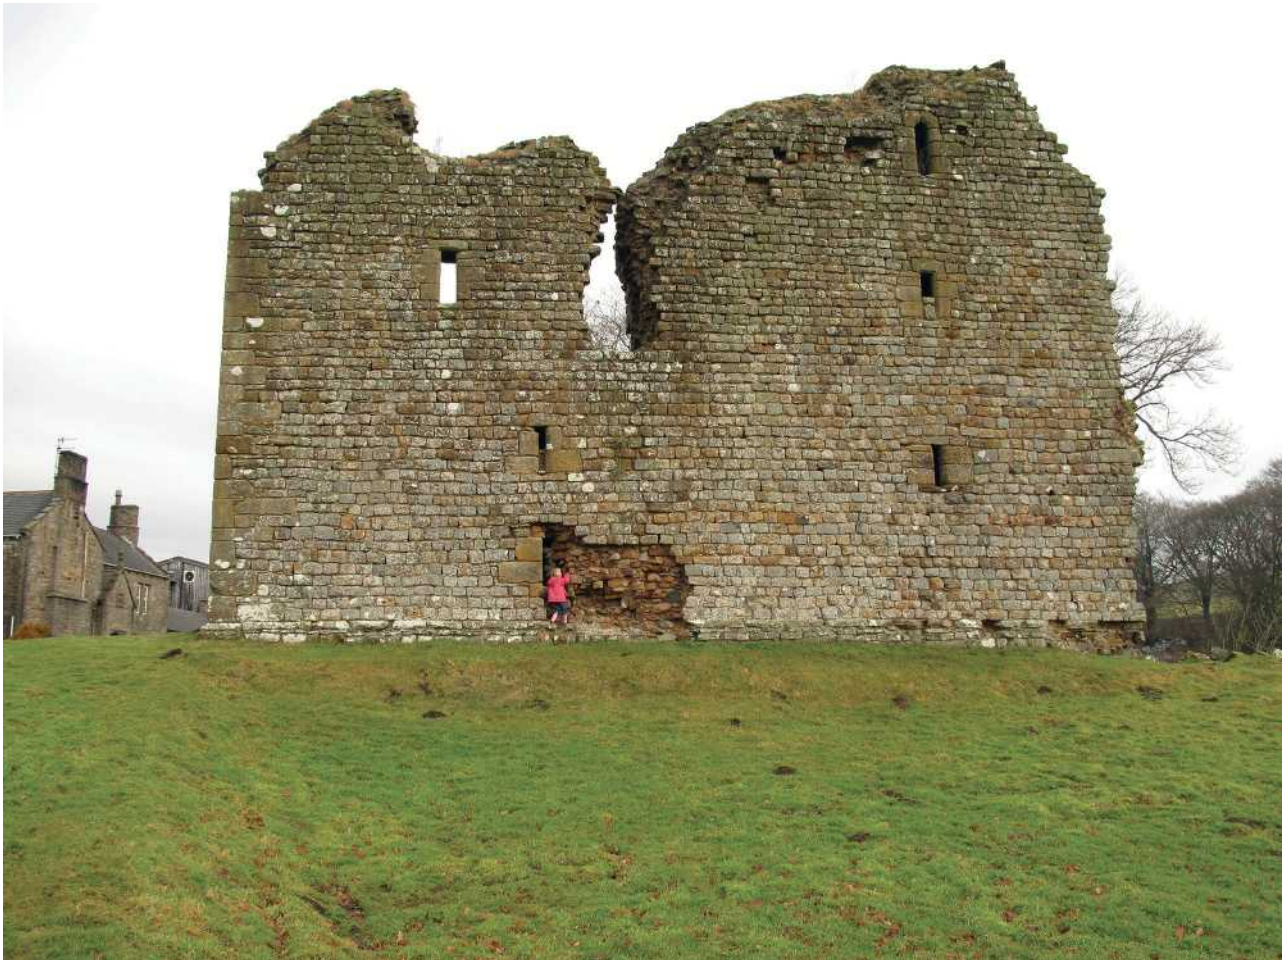
Figure 5.6: Thirlwall Castle, built almost entirely from Roman stones and positioned on a knoll approximately 120 m north of the line of the Wall.

A more instructive and illuminating example of re-used Roman fabric is found at Thirlwall Castle (Fig. 5.6), built on a low spur overlooking the Tipalt-Irthing Gap to the west and approximately 120 m north of the Wall curtain and turret 46a. The castle itself is more technically a stone-built hall house, a fortified hall built in a rectangular tower form, with a solar tower extension off the main block (Rushworth and Carlton 2004, 273; Ryder 2021, 98–99). The stone castle was built in the mid-14th century by the most successful branch of the Thirlwall family and probably succeeds a timber manor house. The castle was built substantially of stone from the Wall, as described by a number of observers (Long 1967, 161; Whitworth 2000, 21; Rushworth and Carlton 2004, 273; Symonds 2020, 138), though alternative sources of building stone remain possible. The use of the Wall as a source of building stone indicates that the Wall was reasonably intact, or at least insufficiently robbed or destroyed to provide a suitable quarry. The Wall was sufficiently present in the late 13th

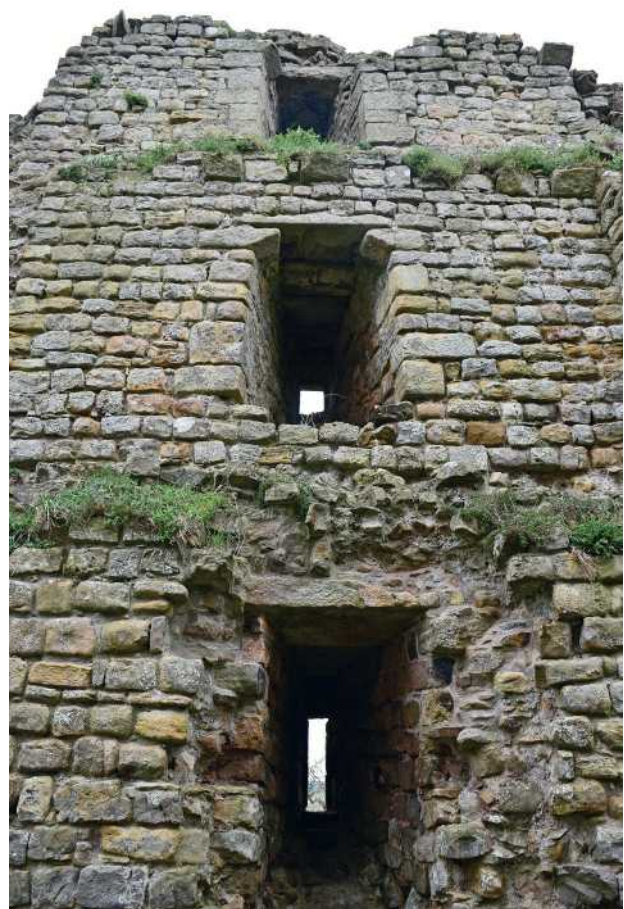
Figure 5.7: The internal face of the south wall of Thirlwall Castle, highlighting the consistent fabric in different sandstones.

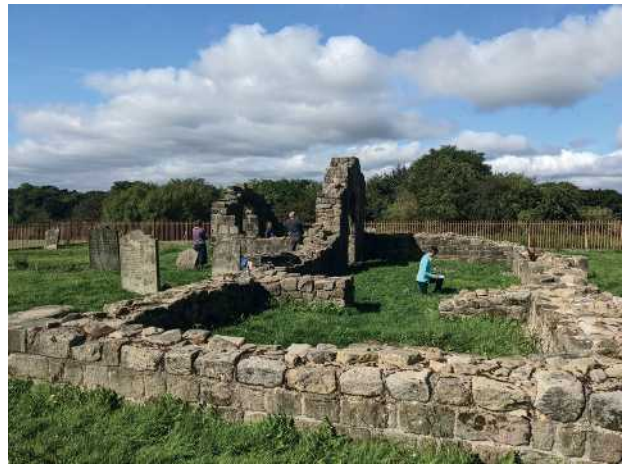
Figure 5.10: The consolidated ruins of Holy Cross Church, Wallsend, located north of the line of Hadrian's Wall. Though largely robbed, some of the remaining stone is re-used Roman fabric.

198; Whitworth 2000, 69), though the exact quantity and full extent of re-used Roman stones is uncertain due to the incomplete nature of the church (Fig. 5.10). Furthermore, the nearest surviving comparative length of curtain is at Buddle Street, Wallsend, and the mixed building at this location that resulted from at least four collapses and rebuilds did not lend itself to direct metric comparison between the two sites. However, other non-Roman stones also survive, such as the voussoirs carved in a medieval Romanesque style with supporting columns, indicating a mixed sourcing for the building's fabric. The closest Wall sites to the church are the fort at Wallsend and the curtain to its west. It seems that these were the most likely sources for the Roman stone, even accepting that some material had already been taken for the construction of Jarrow. Holy Cross is broadly representative of the many churches built throughout the Wall corridor, where some Roman stone can be identified, generally relating to earlier phases in the building's history, but the exact quantity or extant cannot be determined, and sourcing is generally presumed to be the closest locations along the Wall, or another site if off the line of the Wall.

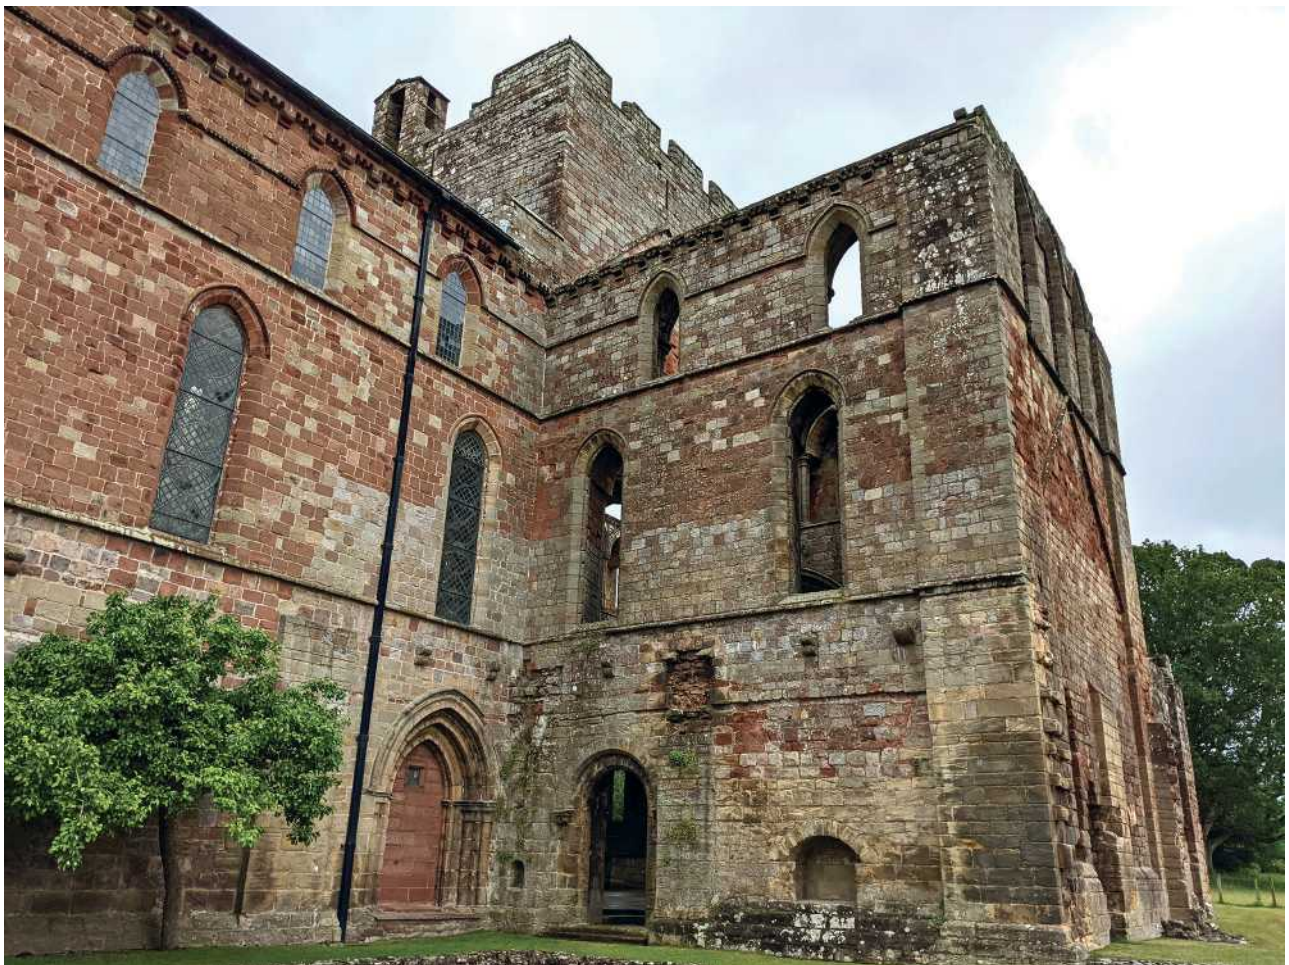
Figure 5.11: The south wall of the nave and west wall of the transept at Lanercost Priory, which makes extensive use of red and white sandstones from Hadrian's Wall.

are built almost entirely from Roman stone (Hill 2000). This stonework can still be viewed today (Fig. 5.11), and it is feasible to broadly correlate building work of the priory with land grants and access to different locations along the Wall (Table 5.3). All told, entries from the *Lanercost Cartulary* indicate that the priory came into possession and had access to 6–8 km of Wall (Todd 1997; Hill 2000, 191), and these have been mapped in Figure 5.12. Examining the fabric of the priory makes it clear that there was access to lengths of Wall built of white/buff sandstone and red sandstone, visible particularly on the south exterior wall of the nave. Based on the phasing of construction, Wall-stone seems to have been employed throughout the building of the priory (Harrison 2000a; 2000b). There are no explicit statements that the Wall was quarried, nor that other locations were quarried. A grant of a stone quarry in 1292 by one Matilda in Gilsland (*Cartulary* no. 242; Todd 1997, 6), however, may indicate either that the Wall had been substantially quarried by that date, or that access was granted to particular rock.

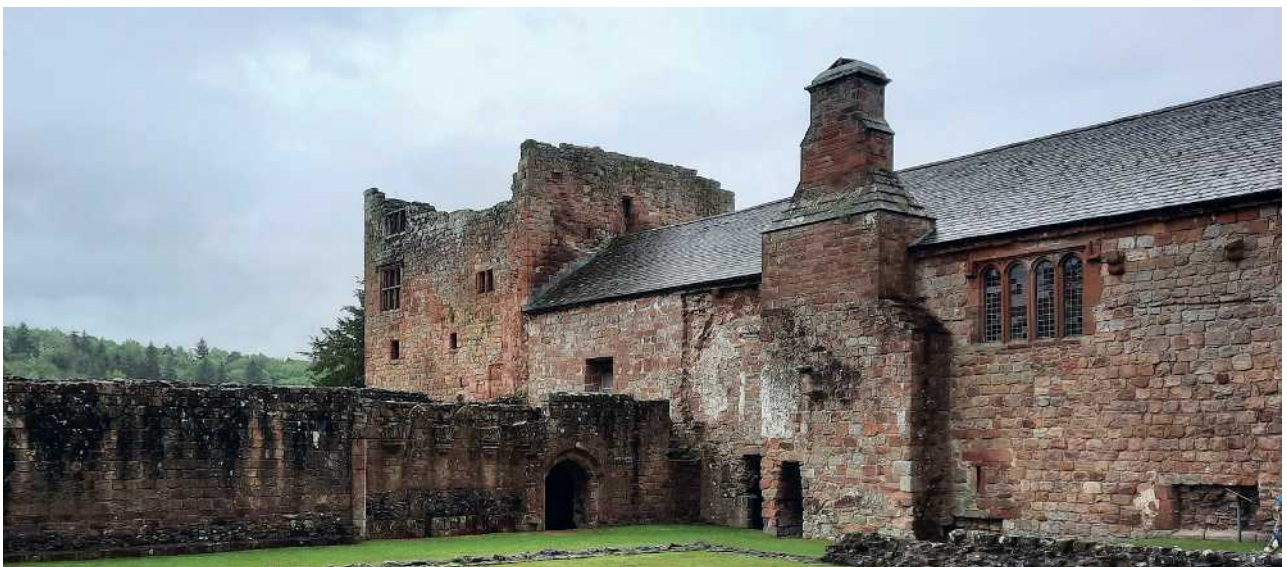
Figure 5.13: The west and south wings of the enclosed cloister of Lanercost, with the west wing and tower built substantially of red sandstone. White sandstones were used in the southern wing (crypt), though the colour is partially obscured by weathering.

The fabric of Lanercost is particularly interesting, not only for what it reveals about its Wall-stone sources, but also what this tells us about the nature of the pre-existing Wall. The Priory is located geologically within the Tyne Limestone Formation, the oldest of the Carboniferous Period Formations underpinning the Wall. It is also within a few hundred metres of the boundary with the overlying Permian sandstones. It is not surprising, therefore, that the stone used in the priory contains a mixture of the pale white and buff sandstones of the Carboniferous Period mixed with the red stone of the Permian and Triassic Periods (Figs 5.11 and 5.13). With a multitude of good Carboniferous sandstone available from the hillside at Banks, east of Hare Hill, it would be unsurprising if the Romans had transported stone west along the Wall from here some way into Permian and Triassic country. There is evidence from a limestone fragment at Cam Beck that this happened and the nearest known source quarry for red sandstone is the Triassic St Bees Sandstone at Gelt some 4 km distant. However, the majority of stone at Cam Beck is Triassic and the large quantities of red sandstone used in the priory suggests sourcing of Wall-stones from further west where such stone was used in the Wall, or (less likely) that these stones are not Roman but merely of Roman size and shape. In either case it is interesting that the red sandstones and pale sandstones are thoroughly intermixed in the fabric of the priory.
