FABRIC *of the* FRONTIER

*Prospection, Use, and Re-Use of Stone
from Hadrian's Wall*

Rob Collins, Ian Kille & Kathleen O'Donnell

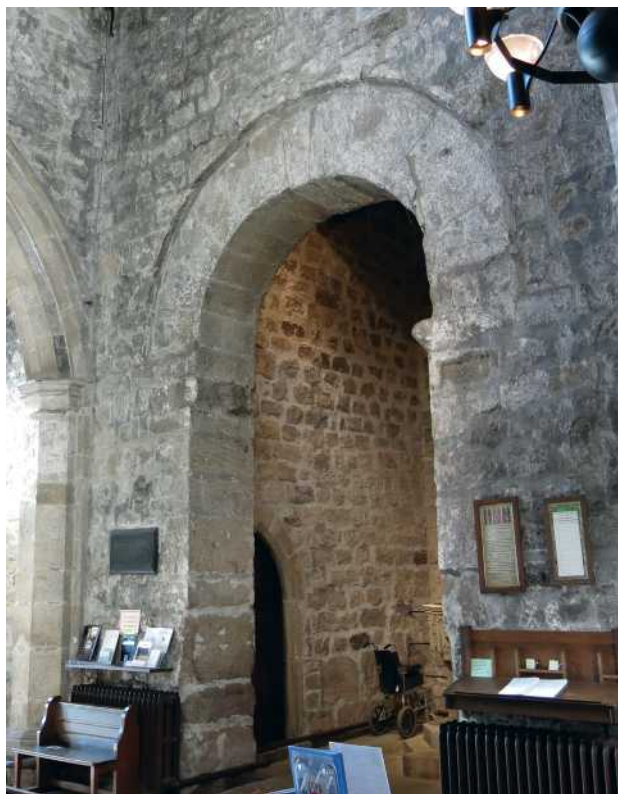
Figure 6.1: A re-used Roman arch, complete with piers, springers, and voussoirs, erected between the nave and the tower at St Andrew's, Corbridge, probably built in the 9th–10th century.

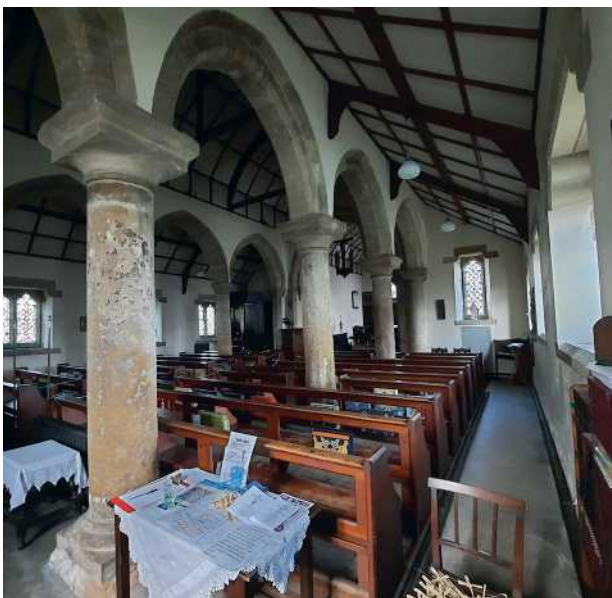
Figure 6.3: Roman columns used in the medieval south arcade of St Giles, Chollerton, probably dating to the 12th–13th centuries.

Medieval structures made much greater use of Roman stonework, presumably accompanied by greater expansion and settlement of the landscape and more extensive use of stone for building. Churches and monastic complexes continued to plunder Roman stone, though perhaps more for functional purposes than the ideological reasons of earlier centuries. This can be seen at varying scales. At St Giles, Chollerton, three monumental Roman columns support the 12th to 13th-century arcade separating the nave from the south aisle (Fig. 6.3). The columns were probably sourced from the nearest fort site at Chesters, though it is possible that Corbridge may have also furnished the columns.
