Self-healing of Structural Composites Containing Dendrimers as Healing Agent

Vassilis Kostopoulos and Athanasios Kotrotsos

Abstract

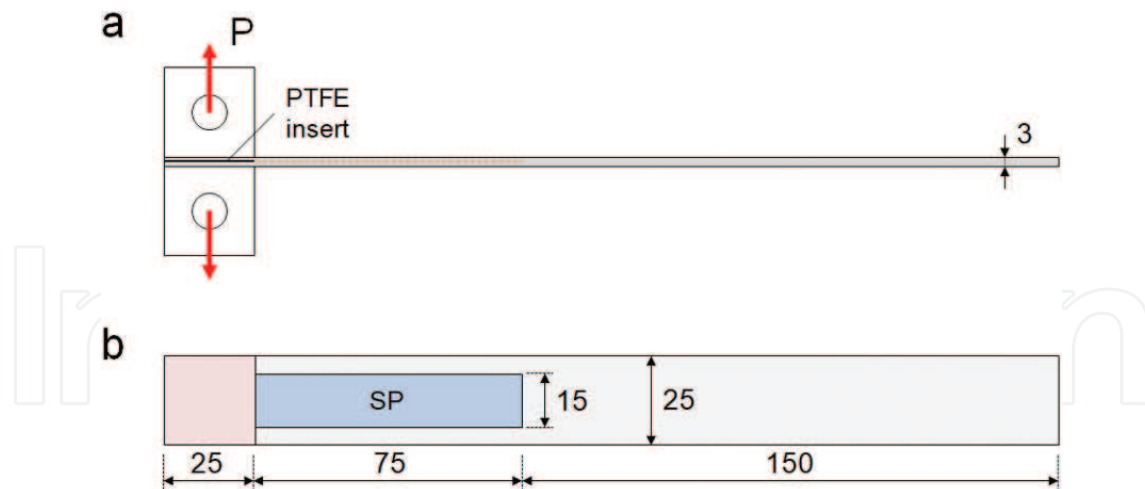
Figure 5. Schematic depiction of the modified DCB test specimen configuration. (a) Side view. (b) Top view. Dimensions in mm.

have a significant effect on the densities and the thicknesses of the samples. Five mode I samples were cut from both the reference and the modified plate. Two aluminum tabs were glued on the DCB specimen outer surfaces (**Figure 5**) using a two-component epoxy adhesive in order to apply the peel/opening forces.

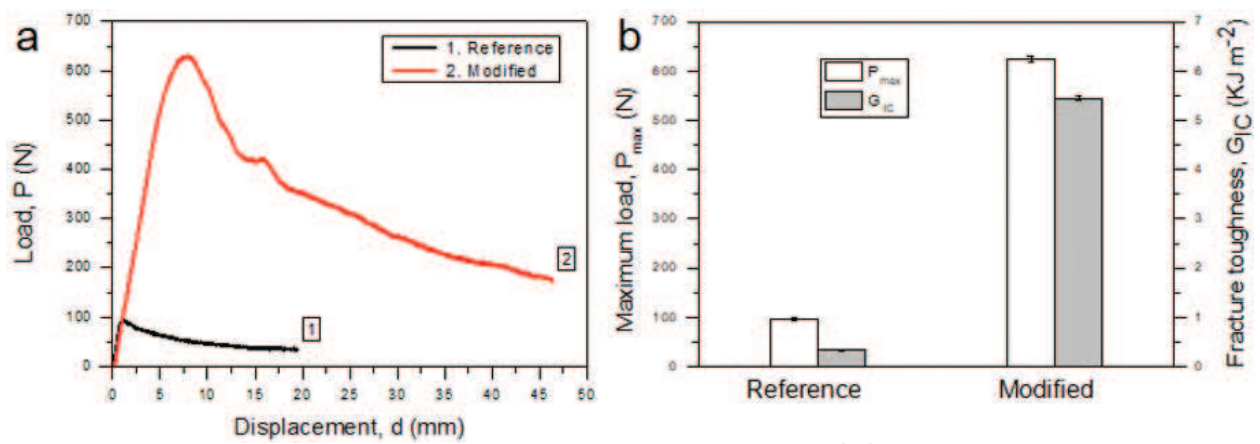
Figure 6. (a) Representative load (P) versus crack opening displacement (d) curves during the mode I interlaminar fracture toughness test of the reference and the modified CFRPs. (b) Comparison between the reference and the modified CFRP in terms of the P_{max} and the G_{IC} values, respectively.

interleaf in its mid-plane, displays a significantly higher P_{max} and calculated G_{IC} , when compared to the reference laminate without SP interleave (**Figure 6(b)**).

fracture toughness. Furthermore, the SP material displayed a high peel resistance. The results clearly show that the presence of the SP interleave in the plate resulted not only in a considerable increase of P_{\max} (545%) but even more into a calculated G_{IC} that was increased with more than one order of magnitude (1550%).

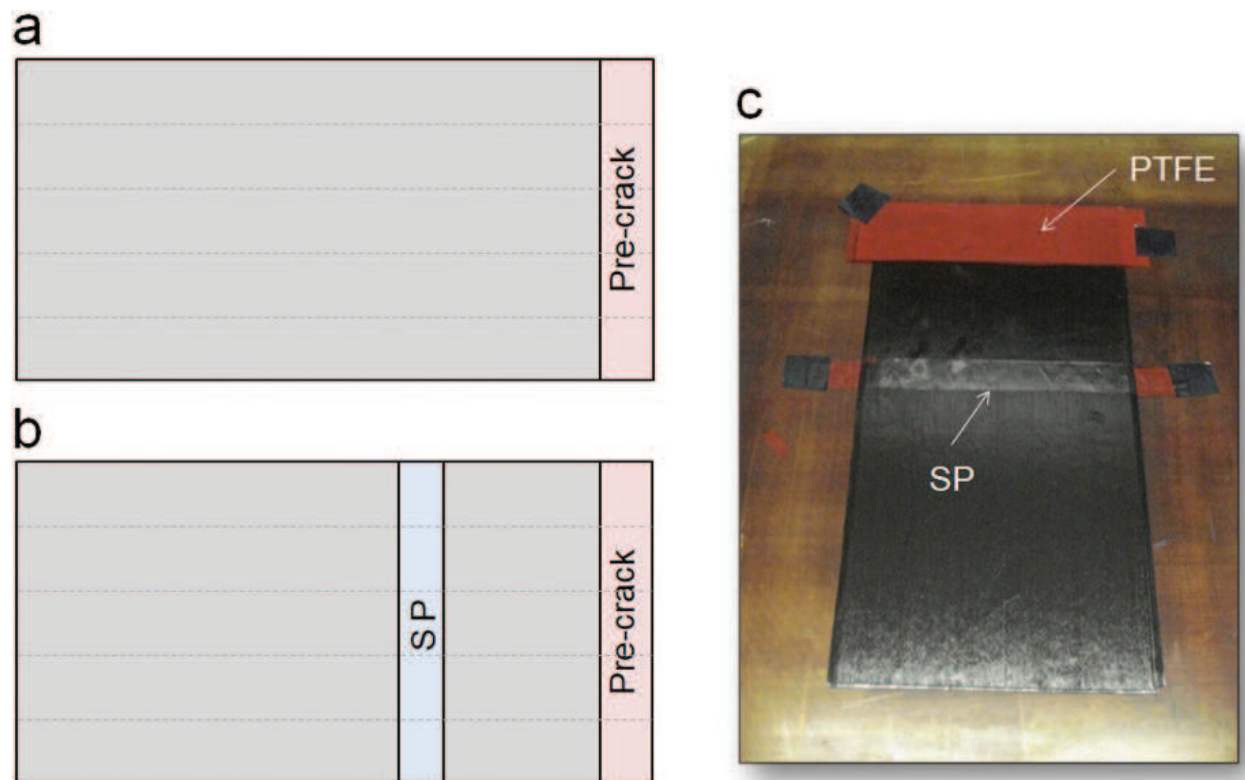
Figure 14. Schematic representation of the mid-plane of (a) the reference plate and (b) the SP containing modified plate. (c) Photograph of the mid-plane of the modified plate, where a SP strip was carefully positioned, together with the PTFE film.

Two UD laminated plates made of 22 prepreg layers were manufactured for the needs of the current study; the reference laminate and the modified laminate containing the SP interleaf on the mid-plane, both appropriate for deriving mode II interlaminar fracture specimens. **Figure 14** shows schematically the plate configuration with respect to the fracture pre-crack and the SHA location. During the manufacturing process, two 13- μm -thick sheets of PTFE film were placed in the mid-thickness plane of both laminates as shown in **Figure 14** to act as initial pre-crack according to the request of the interlaminar fracture test. In the case of the modified laminate, a SP strip was carefully placed on the mid-plane as shown in **Figure 14(b, c)**. Following the lay-up, the laminates were vacuum bagged and cured in autoclave for 2 h at 130°C under 6 bar pressure, according to the prepreg supplier guidelines. The dimensions of the plates were 300 mm \times 150 mm \times 3 mm. Five mode I (DCB) samples were cut from both the reference and the modified plate. The incorporation of the SP film in the mid-plane of the modified laminate did not appear to have a significant effect on the thicknesses of the samples. The fiber volume fraction of all manufactured plates was calculated to be close to 60%.

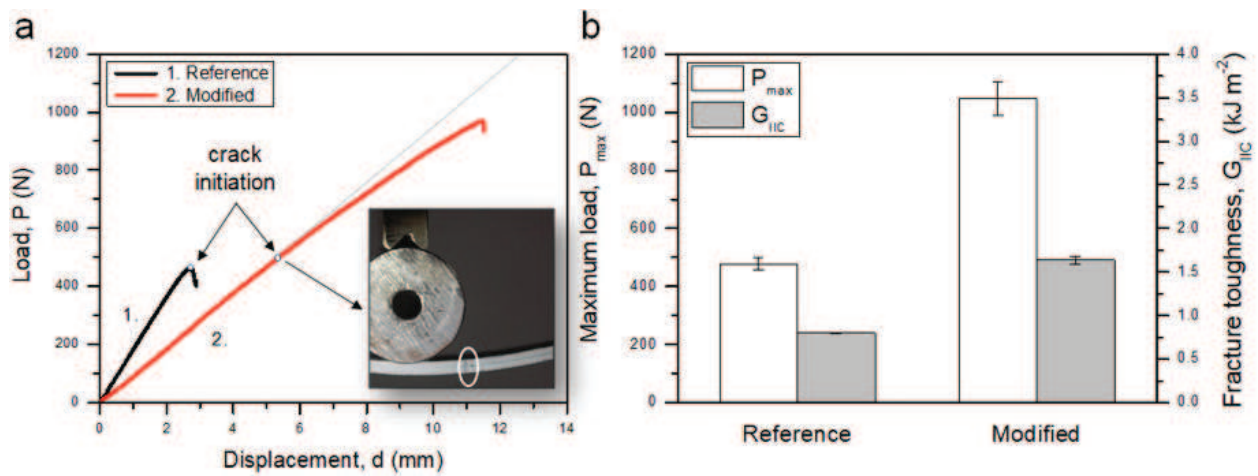
Figure 17. (a) Representative load (P) versus displacement (d) curves for the reference and modified CFRPs during the mode II interlaminar fracture toughness test. (b) Comparison between the reference and the modified CFRP, for the P_{max} and the G_{IIC} values, respectively.

Typical load-displacement (P-d) curves for the reference and the modified plate are given in **Figure 17(a)**. All specimens within each set showed a similar behavior. The average values and standard deviation for the two material sets are shown in **Figure 17(b)**. As previously mentioned, the P-d behavior of the two material sets differs. For the reference material, the applied load increases linearly until the onset of the pre-crack propagation where the load drops abruptly. On

the other hand, for the modified CFRP, the initially linear P - d relation is followed by a distinguishable deviation from linearity and much latter the load drop appears. Whereas the load drop for the reference case is attributed to the crack evolution onset, for the modified CFRP the P_{max} indicates the load-bearing capacity of the composite before undergoing major damages. Interestingly, the modified laminate exhibits a significantly higher P_{max} and respective displacement. As seen in the **Figure 17(a)**, P_{max} is more than double that of the reference CFRP (120% increase) while the displacement at failure is approximately four times larger than the reference.

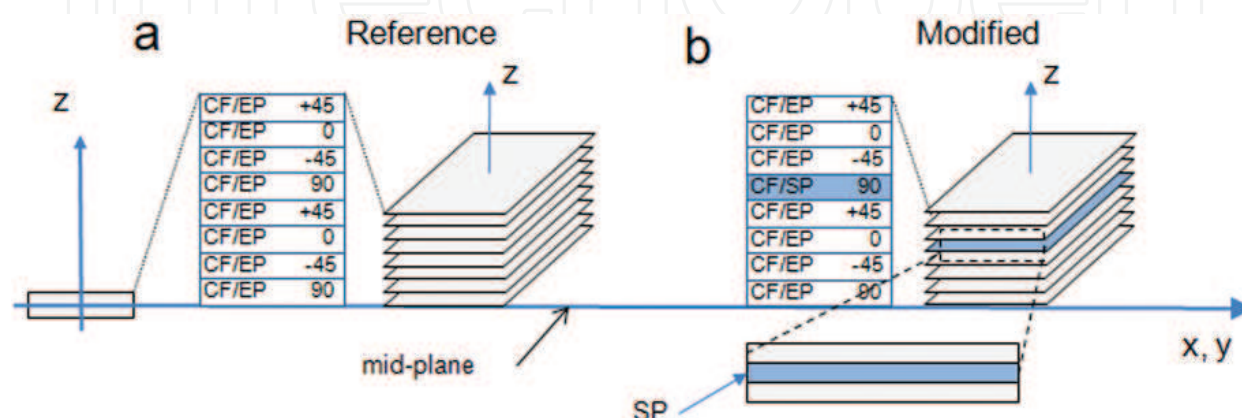
Figure 20. Design of (a) the reference CFRP, (b) the modified CFRP with SP prepregs.

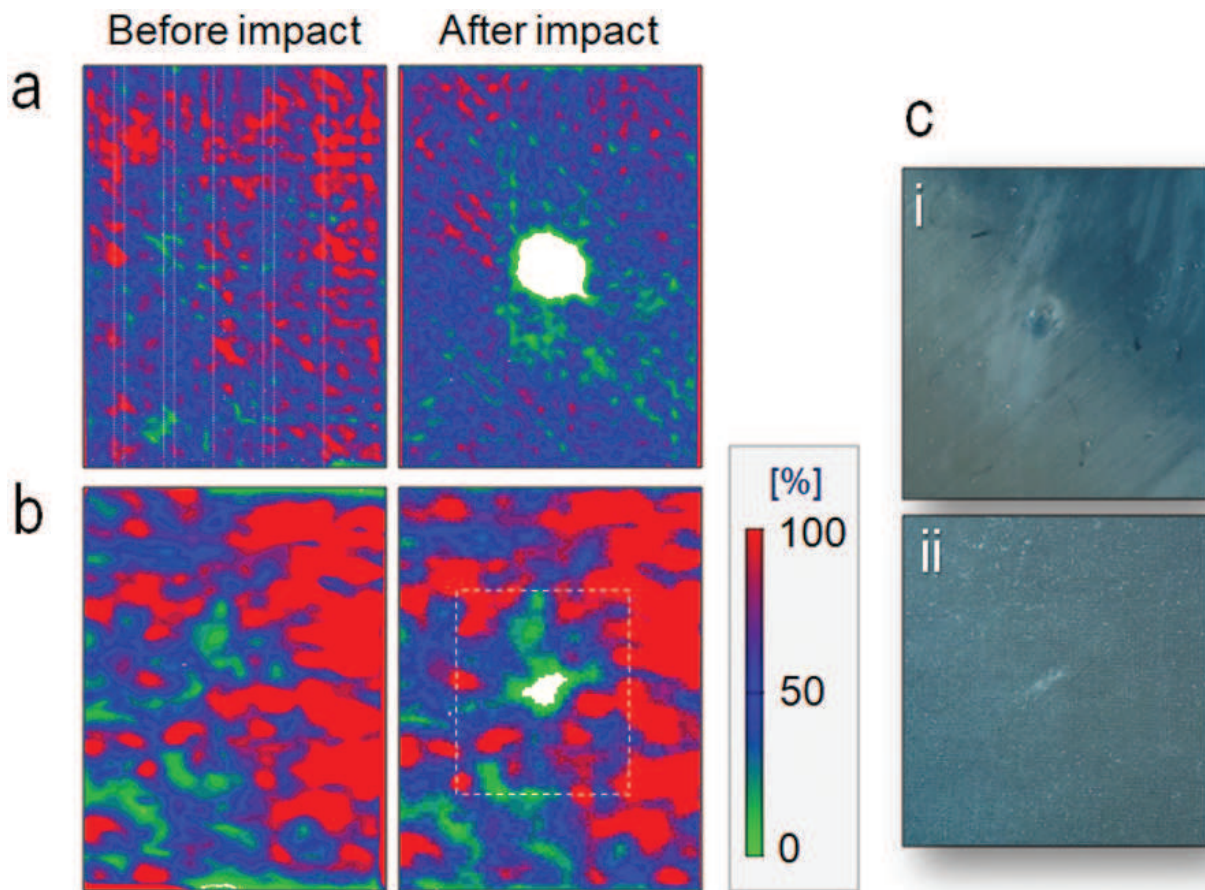
Figure 22. Representative C-scan inspection images of the (a) reference CFRP, (b) modified CFRP with SP prepregs in the before and after the LVI situation. (c) Indicative top- and bottom-face photographs after LVI for the SP prepeg-modified composites.

Reference and modified CFRPs were subjected to LVI as described in Section 2.1.5. After testing, C-scan inspection measurements were performed to evaluate the impact-induced damage. The typical C-scans for all material types in the before and after impact situations are shown in **Figure 22(a, b)**. The white region in the center of the images in **Figure 22(a, b)** represents the damage area (mainly delamination) induced by the impact event. For the determination of the impact damage area, post-processing software was utilized. The software was able to quantify the white region area (damage area) of the recorded C-scan images after the LVI event for both material sets. These areas were calculated to be approximately 592 and 115 mm² for the reference and the modified plates, respectively. Thus, the modified composites exhibit higher resistance to delamination, compared against the reference ones. The incorporation of the SHA in prepreg form into composite laminate increases the LVI damage resistance of the final material. The SP prepreg provides higher energy absorption characteristics to the entire composite due its ductile nature, during LVI. In the present work impact energy of 25 J was used. It is considered a moderate amount of impact energy that does not occurs fiber breakage and the main damage mode that is promoted is delamination. In fact, no visible or detectable damage was shown on the top and bottom faces of the reference samples after LVI testing. On the contrary, optical inspection of SP-modified prepreg samples exhibited only indentation on the top face (**Figure 22(cii)**), while no ply splitting phenomena were observed on the bottom face of the CFRP plate (**Figure 22(cii)**).

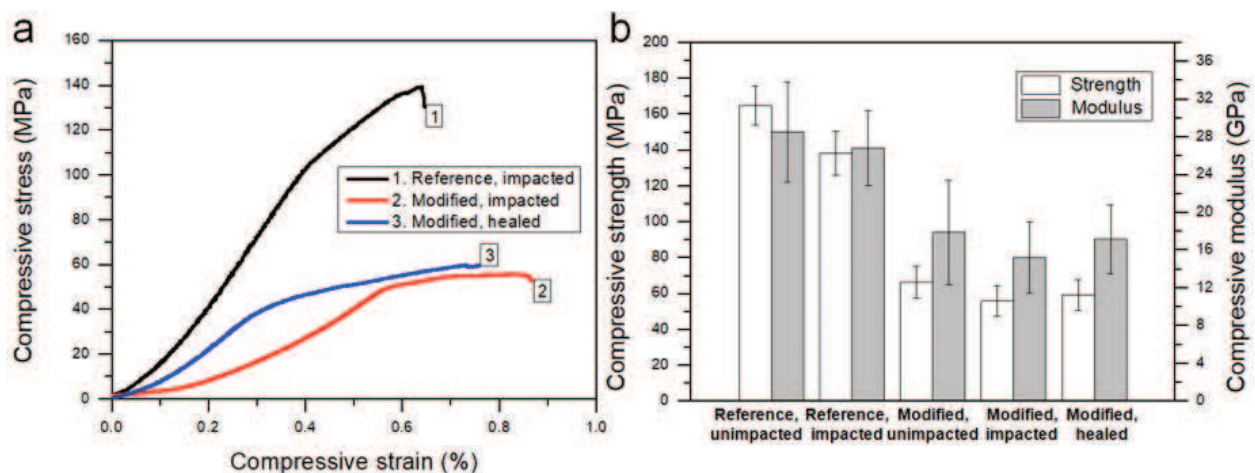
Figure 27. (a) Representative compressive stress versus compressive strain (%) curves from the CAI testing of both the reference and modified CFRPs (prior and after healing). (b) σ_{\max} and E_{comp} values of both the reference and modified CFRPs prior impact, after impact and after healing.

Typical compressive stress versus compressive strain (%) curves after LVI for reference and SP-modified samples (prior and after healing) are illustrated in **Figure 27(a)**. In addition, σ_{\max} and E_{comp} values of both the reference and modified CFRPs in prior impact, after impact and after healing situation are summarized in **Figure 27(b)**. According to these results, it is shown that after LVI, the σ_{\max} of the reference samples was reduced by 16%. SP modified samples, exhibited also the same reduction (16%) for the σ_{\max} value. The reduction of the apparent compressive modulus (E_{comp}) is 5% for the reference and 9% for the SP-modified CFRPs. Furthermore, the SP-modified samples passed through healing process as it is has been already described earlier, and after that they exposed to CAI tests in order the post-healing performance of the composite plates to be investigated. According to these tests, it was shown that healed samples presented higher σ_{\max} and E_{comp} values approximately 6 and 42%, respectively compared against the unhealed SP-modified ones (impacted samples). Therefore, modified samples improved CAI properties via healing treatment.
